Access Compliance Report

Public Rights-of-Way

(Curb Ramps)

| Intersection ID: 28104 | Main Street: CRUDEN_BAY_WY | Cross Street: DELMAHOY_DR | Location: SE |

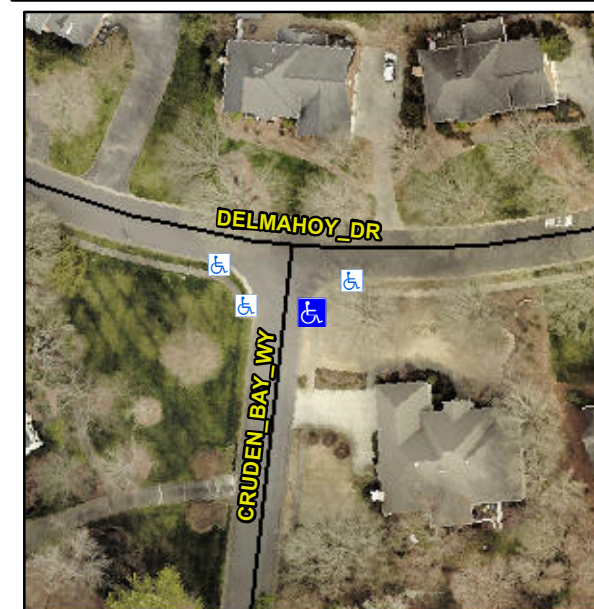
| ADA ID: 42820739DC4C | Ramp Type: Perp | Initial Pass/Fail: Fail | Overall Compliance: No |
| Severity Score: 33.75 | | | |

Not Found, R304.5.1, R304.2.2, R304.5.3

| Compliance | Description | Data | Compliance | Description | Data |
|---|---|---|---|---|---|
| N/A | Ramp Length (in) | 96.0 | No | Ramp Slope (%) | 8.4 |
| No | Ramp Width (in) | 46.0 | No | Ramp XSlope (%) | 5.7 |

Remove & Replace Entire Ramp.

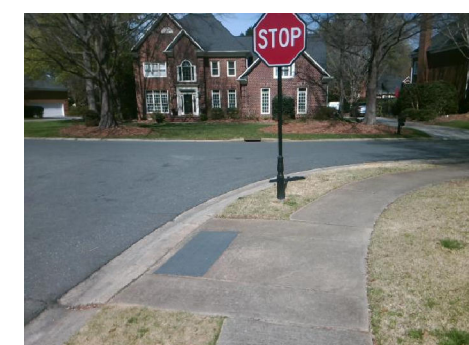
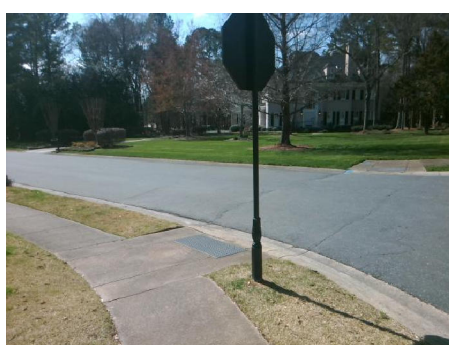
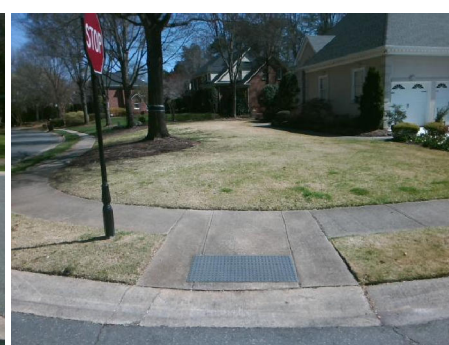
| Compliance | Description | Data | Compliance | Description | Data |
|---|---|---|---|---|---|
| | | | Yes | Surface Condition? (G/P) | Good |
