Access Compliance Report

Public Rights-of-Way

(Curb Ramps)

Intersection ID: 8652	Main Street: ERIE_ST	Cross Street: HATERAS_AV	Location: SE
ADA ID: 4284B950FF6A	Ramp Type: PerpDiag	Initial Pass/Fail: Fail	Overall Compliance: No
			Severity Score: 13.75

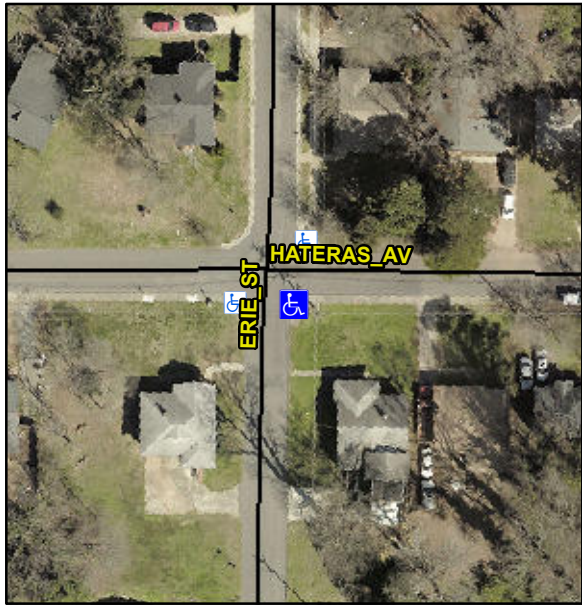
</div> <div>Street 1 NameHATERAS AV</div> <div>Stop Condition-Street 2None</div> <div>Street 2 NameERIE ST</div> <div>Stop Condition-Street 1StopSign</div> <div>Possible Solutions: Remove & Replace Curb Ramp With Two New Directional Ramps or Equivalent.</div> <div>Surveyor Notes: N/A</div> <div>PROW/ADA: Not Found, R304.2.2, R304.5.3</div> <div>Total Cost:\$3200.00</div>			Compliance	Description	Data	Compliance	Description	Data
			N/A	Ramp Length (in)	42.0	No	Ramp Slope (%)	9.6
			Yes	Ramp Width (in)	48.0	No	Ramp XSlope (%)	2.9
			N/A	Flare Type LT	N/A	N/A	Flare Type RT	N/A
			N/A	Flare Slope LT (%)	N/A	N/A	Flare Slope RT (%)	N/A
			N/A	Flare Traversable LT?	N/A	N/A	Flare Traversable RT?	N/A
			N/A	Landing Length (in)	N/A	N/A	DWS Provided?	N/A
			N/A	Landing Width (in)	N/A	N/A	DWS Contrast?	N/A
			N/A	Landing Slope (%)	N/A	N/A	DWS Length (in)	N/A

N/A	Landing X Slope (%)	N/A	N/A	DWS Full Width?	N/A
			N/A	Landing Curb? (Y/N)	N/A	N/A	DWS Offset (in)	N/A
			N/A	Shared Landing?	N/A			
			N/A	Gutter Ponding?	N/A	N/A	Gutter Slope (%)	N/A
			N/A	Gutter Lip Ht (in)	N/A	N/A	Gutter X Slope (%)	N/A
			N/A	Painted X Walk1?	No	N/A	Painted X Walk2?	No
				X Walk 1 Direction	To N		X Walk 2 Direction	To W
			N/A	X Walk 1 Width (in)	N/A	N/A	X Walk 2 Width (in)	N/A
				X Walk 1 Slope (%)	6.2		X Walk 2 Slope (%)	5.9
				X Walk 1 X Slope (%)	4.6		X Walk 2 X Slope (%)	7.6
			N/A	Ramp inside XWalk1?	N/A	N/A	Ramp inside XWalk2?	N/A
	Road Slope (%)	0.4	N/A	Clear Space?	N/A			
	Road X Slope (%)	9.9	N/A	Clear Space to XWalk (in)	N/A			
N/A	Any Obstructions?	N/A	N/A	Storm Grate/Utility Hazard?	N/A			
	Obstruction Type			Storm Grate/Utility Type				
			N/A		N/A			
			Yes	Surface Condition? (G/P)	Good
