Access Compliance Report

Public Rights-of-Way

(Curb Ramps)

| Intersection ID: 10025963 | Main Street: ELM_LN | Cross Street: N/A | Location: NW |

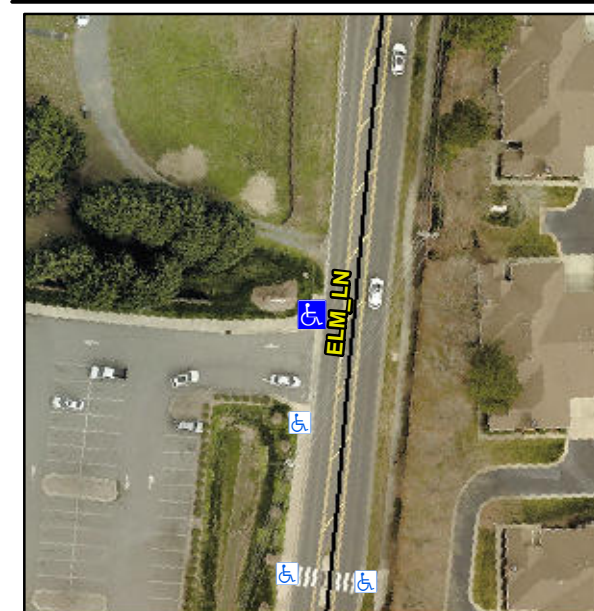
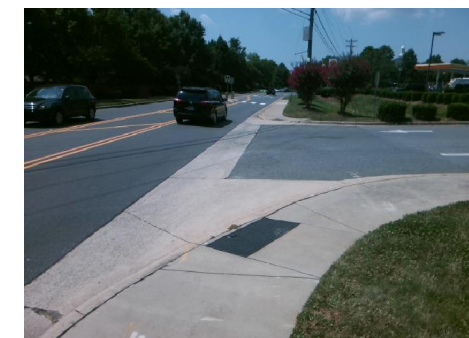
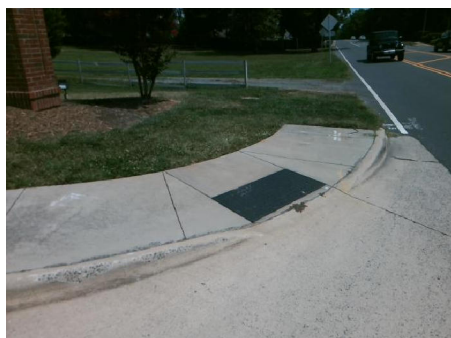
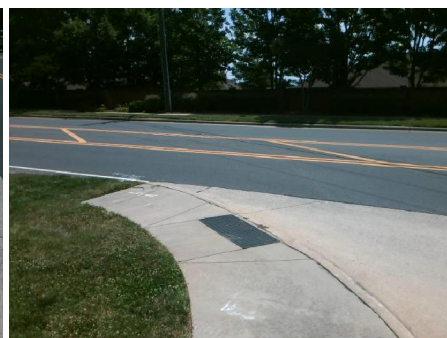
| ADA ID: 429287C09570 | Ramp Type: PerpDiag | Initial Pass/Fail: Fail | Overall Compliance: No |

Not Found, R304.5.1, R304.2.2

| Compliance | Description | Data | Compliance | Description | Data |
|---|---|---|---|---|---|
| N/A | Ramp Length (in) | 54.0 | No | Ramp Slope (%) | 10.3 |
| No | Ramp Width (in) | 46.5 | Yes | Ramp XSlope (%) | 1.0 |

Remove & Replace Curb Ramp With Two New Directional Ramps or Equivalent.
