# Access Compliance Report

## Public Rights-of-Way

### (Curb Ramps)

| Intersection ID: 45096 | Main Street: E_9TH_ST | Cross Street: N_DAVIDSON_ST | Location: SE |

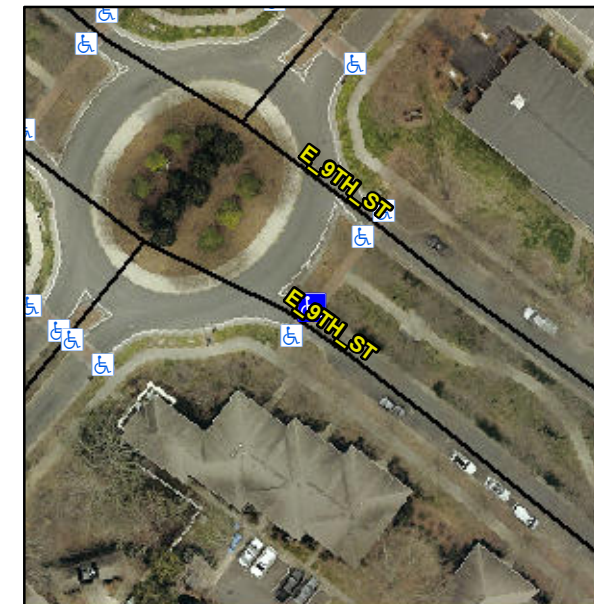
**R304.2.2, R304.5.3**

| Compliance | Description | Data | Compliance | Description | Data |
|---|---|---|---|---|---|
| N/A | Ramp Length (in) | 69.0 | No | Ramp Slope (%) | 10.1 |
| Yes | Ramp Width (in) | 71.0 | No | Ramp XSlope (%) | 2.7 |

**Remove & Replace Entire Ramp.**
