## **Access Compliance Report Public Rights-of-Way** (Curb Ramps)

Main Street: N PINE ST Cross Street: W 12TH ST Intersection ID: 11264 Location: NW Initial Pass/Fail: Fail **Overall Compliance: No** ADA ID: 4297FE790919 Ramp Type: Combination2 **Severity Score:** 55

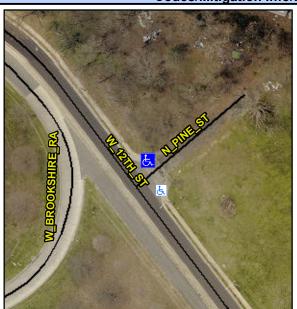
Possible Solutions: Compliance Description N/A Remove & Replace Entire Ramp. No No No N/A No Surveyor Notes: N/A RT RP < 5% N/A N/A N/A N/A PROW/ADA: N/A Not Found, R304.5.1, R304.5.1, N/A R304.5.3, R304.3.2 N/A N/A N/A N/A N/A
