Access Compliance Report Public Rights-of-Way (Curb Ramps)

Intersection ID: 45439 Main St		reet: HENDERSON_OAKS_DR	Cross	Cross Street: HENDERSON_VALLEY_LN				Location:	NE
ADA ID: 429A2B60C810 Ramp T		Гуре: PerpDiag lı		itial Pass/Fail: Fail Overall Compliance: No				o Severity Score:	21.25
Codes/Mitigation Info/Possible Solution				Field Measurements/Component Compliance

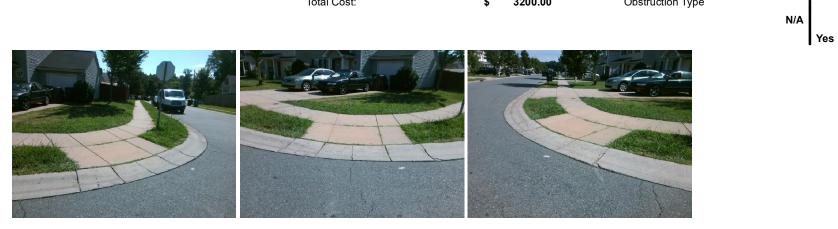
-	Possible Solutions:		Compliance Description			Data Compliance Description		Data
		Remove & Replace Curb Ramp	With	N/A	Ramp Length (in)	49.0	No	Ramp Slope (%)	9.5
		Two New Directional Ramps or		No	Ramp Width (in)	47.0	Yes	Ramp XSlope (%)	1.1
		Equivalent.		N/A	Flare Type LT	N/A	N/A	Flare Type RT	N/A
				N/A	Flare Slope LT (%)	N/A	N/A	Flare Slope RT (%)	N/A
