# Access Compliance Report

## Public Rights-of-Way

### (Curb Ramps)

Intersection ID: 45784	Main Street: CRABAPPLE_TREE_LN	Cross Street: LONG_HILL_DR	Location: W
ADA ID: 429F0532E786	Ramp Type: PerpDiag	Initial Pass/Fail: Fail	Overall Compliance: No
Severity Score: 22.5			
Codes/Mitigation Info/Possible Solution		Field Measurements/Component Compliance

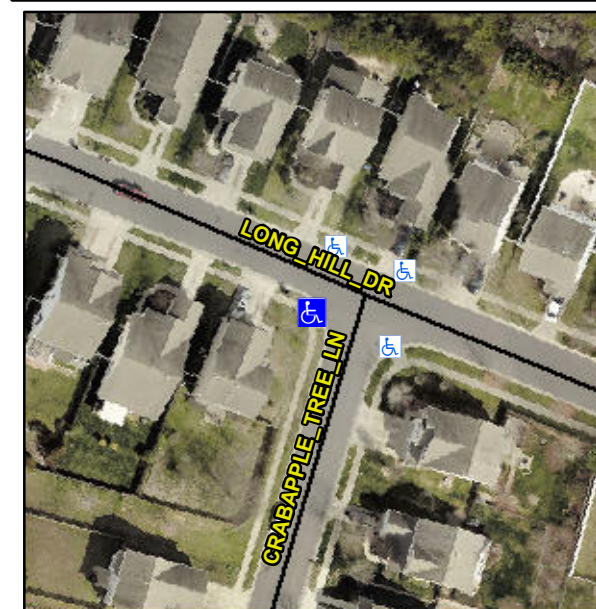
Compliance	Description	Data	Compliance	Description	Data
N/A	Ramp Length (in)	91.5	No	Ramp Slope (%)	9.3
No	Ramp Width (in)	47.0	No	Ramp XSlope (%)	4.8
N/A	Flare Type LT	N/A	N/A	Flare Type RT	N/A
N/A	Flare Slope LT (%)	N/A	N/A	Flare Slope RT (%)	N/A
N/A	Flare Traversable LT?	N/A	N/A	Flare Traversable RT?	N/A
N/A	Landing Length (in)	N/A	N/A	DWS Provided?	N/A
N/A	Landing Width (in)	N/A	N/A	DWS Contrast?	N/A
N/A	Landing Slope (%)	N/A	N/A	DWS Length (in)	N/A
N/A	Landing X Slope (%)	N/A	N/A	DWS Full Width?	N/A
N/A	Landing Curb? (Y/N)	N/A	N/A	DWS Offset (in)	N/A
N/A	Shared Landing?	N/A			
N/A	Gutter Ponding?	N/A	N/A	Gutter Slope (%)	N/A
N/A	Gutter Lip Ht (in)	N/A	N/A	Gutter X Slope (%)	N/A
N/A	Painted X Walk1?	No	N/A	Painted X Walk2?	No
	X Walk 1 Direction	To SE		X Walk 2 Direction	To NE
N/A	X Walk 1 Width (in)	N/A	N/A	X Walk 2 Width (in)	N/A
	X Walk 1 Slope (%)	4.2		X Walk 2 Slope (%)	4.6
	X Walk 1 X Slope (%)	4.3		X Walk 2 X Slope (%)	1.5

N/A	Ramp inside XWalk1?	N/A	N/A	Ramp inside XWalk2?	N/A
	Road Slope (%)	2.2	N/A	Clear Space?	N/A
	Road X Slope (%)	4.0	N/A	Clear Space to XWalk (in)	N/A
N/A	Any Obstructions?	N/A	N/A	Storm Grate/Utility Hazard?	N/A
	Obstruction Type			Storm Grate/Utility Type	
		N/A			N/A
			Yes	Surface Condition? (G/P)	Good

Possible Solutions:

**Remove & Replace Curb Ramp With Two New Directional Ramps or Equivalent.**

**Not Found, R304.5.1, R304.2.2, R304.5.3**
