Access Compliance Report

Public Rights-of-Way

(Curb Ramps)

Intersection ID: 14720	Main Street: E_5TH_ST	Cross Street: N_DOTGER_AV	Location: W
ADA ID: 42AB42FBC023	Ramp Type: Directional1	Initial Pass/Fail: Fail	Overall Compliance: No
		Severity Score: 12.5

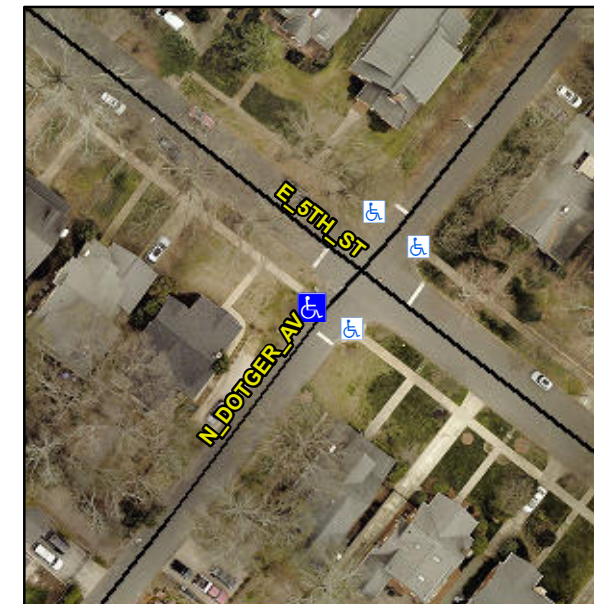
Compliance	Description	Data	Compliance	Description	Data
N/A	Ramp Length (in)	364.0	N/A	Grade Break?	N/A
Yes	Ramp Width (in)	59.0	N/A	Grade Break Slope (%)	0.0
Yes	Ramp Slope (%)	9.5	N/A	Grade Break XSlope (%)	0.0
Yes	Ramp XSlope (%)	0.6			
N/A	Flare Type LT	N/A	N/A	Flare Type RT	N/A
N/A	Flare Slope LT (%)	N/A	N/A	Flare Slope RT (%)	0.0
N/A	Flare Traversable LT?	N/A	N/A	Flare Traversable RT?	N/A
N/A	Landing Length (in)	0.0	N/A	DWS Provided?	N/A
N/A	Landing Width (in)	0.0	N/A	DWS Contrast?	N/A
N/A	Landing Slope (%)	0.0	N/A	DWS Length (in)	N/A
N/A	Landing X Slope (%)	0.0	N/A	DWS Full Width?	N/A
N/A	Landing Curb? (Y/N)	N/A	N/A	DWS Offset LT (in)	N/A
N/A	Shared Landing?	N/A	N/A	DWS Offset RT (in)	N/A
N/A	Gutter Ponding?	0.0	N/A	Gutter Slope (%)	N/A
N/A	Gutter Lip Ht (in)	0.0	N/A	Gutter X Slope (%)	N/A
N/A	Painted X Walk1?	No		Road Slope (%)	0.3
	X Walk 1 Direction	To SE		Road X Slope (%)	1.7
	X Walk 1 Width (in)	N/A		Clear Space?	N/A

X Walk 1 Slope (%)	0.3	N/A	Clear Space to XWalk (in)	N/A
	X Walk 1 X Slope (%)	1.7	N/A	Storm Grate/Utility Hazard?	N/A
N/A	Ramp inside XWalk1?	N/A		Storm Grate/Utility Type	
N/A	Any Obstructions?	N/A			N/A
	Obstruction Type		Yes	Surface Condition? (G/P)	Good
			N/A	Curb Slope (%)	5.8

Possible Solutions:

Remove & Replace Entire Ramp.
