# Access Compliance Report

## Public Rights-of-Way

### (Curb Ramps)

| Intersection ID: N/A | Main Street: E_4TH_ST | Cross Street: S_CALDWELL_ST | Location: W |

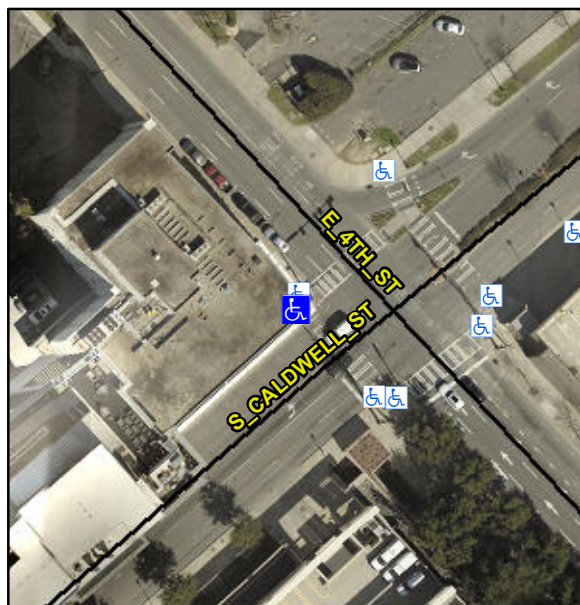
| ADA ID: 42AF0BA8D0E8 | Ramp Type: Directional2 | Initial Pass/Fail: Pass | Overall Compliance: No |

**Not Found, R304.2.2-Perp, R304.3.2-Para, R304.5.3**

| Compliance | Description | Data | Compliance | Description | Data |
|---|---|---|---|---|---|
| Yes | Ramp Width (in) | 48.0 | No | Grade Break Slope (%) | 10.4 |
| No | Landing Slope (%) | 6.9 | Yes | DWS Length (in) | 37.0 |

**Remove & Replace Entire Ramp.  
Remove & Replace Gutter.**

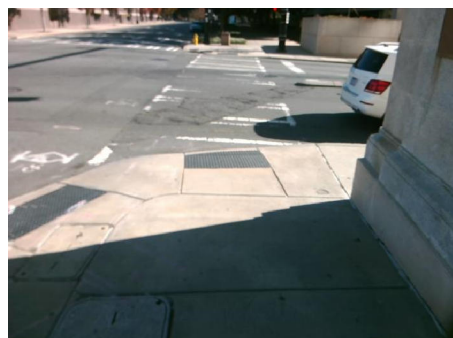
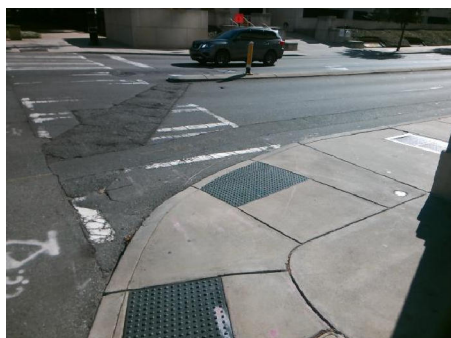
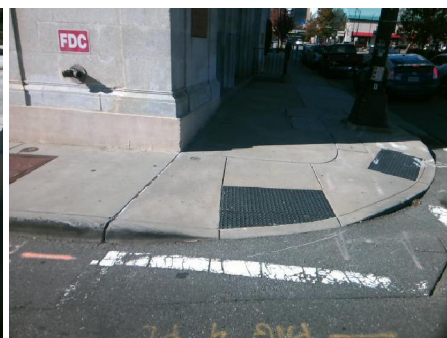
| Severity Score: 2.5 | | | |

| Compliance | Description | Data | Compliance | Description | Data |
|---|---|---|---|---|---|
| Yes | Gutter Lip Ht (in) | 0.0 | No | Gutter X Slope (%) | 3.4 |

Possible Solutions:
