# Access Compliance Report

## Public Rights-of-Way

### (Curb Ramps)

Intersection ID: 14659	Main Street: E_WORTHINGTON_AV	Cross Street: SPRINGDALE_AV	Location:	N
ADA ID: 42B6A205271F	Ramp Type: Perp	Initial Pass/Fail: Fail	Overall Compliance: No	Severity Score: 35

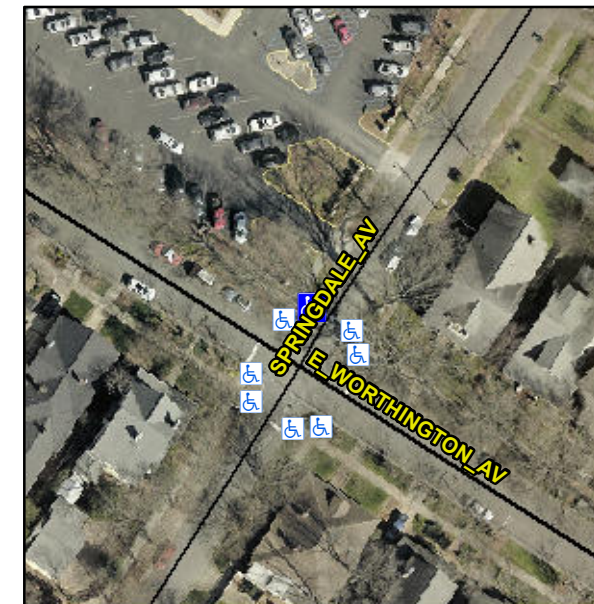
**Not Found, R304.5.1, R304.2.2, R304.5.3**

Compliance	Description	Data	Compliance	Description	Data
N/A	Ramp Length (in)	51.0	No	Ramp Slope (%)	12.8
No	Ramp Width (in)	36.0	No	Ramp XSlope (%)	2.5
N/A	Flare Type LT	N/A	N/A	Flare Type RT	N/A
N/A	Flare Slope LT (%)	N/A	N/A	Flare Slope RT (%)	N/A
N/A	Flare Traversable LT?	N/A	N/A	Flare Traversable RT?	N/A
N/A	Landing Length (in)	N/A	N/A	DWS Provided?	N/A
N/A	Landing Width (in)	N/A	N/A	DWS Contrast?	N/A
N/A	Landing Slope (%)	N/A	N/A	DWS Length (in)	N/A
N/A	Landing X Slope (%)	N/A	N/A	DWS Full Width?	N/A
N/A	Landing Curb? (Y/N)	N/A	N/A	DWS Offset (in)	N/A
N/A	Shared Landing?	N/A			
N/A	Gutter Ponding?	N/A	N/A	Gutter Slope (%)	N/A
N/A	Gutter Lip Ht (in)	2.0	N/A	Gutter X Slope (%)	N/A
N/A	Painted X Walk1?	No	N/A	Painted X Walk2?	N/A
	X Walk 1 Direction	To SE		X Walk 2 Direction	N/A
N/A	X Walk 1 Width (in)	N/A	N/A	X Walk 2 Width (in)	N/A
	X Walk 1 Slope (%)	6.4		X Walk 2 Slope (%)	N/A
	X Walk 1 X Slope (%)	2.1		X Walk 2 X Slope (%)	N/A

N/A	Ramp inside XWalk1?	N/A	N/A	Ramp inside XWalk2?	N/A
	Road Slope (%)	N/A	N/A	Clear Space?	N/A
	Road X Slope (%)	N/A	N/A	Clear Space to XWalk (in)	N/A
N/A	Any Obstructions?	N/A	N/A	Storm Grate/Utility Hazard?	N/A
	Obstruction Type			Storm Grate/Utility Type	
		N/A			N/A
			Yes	Surface Condition? (G/P)	Good

**Remove & Replace Entire Ramp.**

Total Cost: \$ 1850.00
