Access Compliance Report

Public Rights-of-Way (Curb Ramps)

| Intersection ID: 44216 | Main Street: ROZZELLES_FERRY_RD | Cross Street: ROZZELLES_LANDING_DR | Location: S |
| ADA ID: 42CBA6C81CF9 | Ramp Type: Perp | Initial Pass/Fail: Fail | Overall Compliance: No |

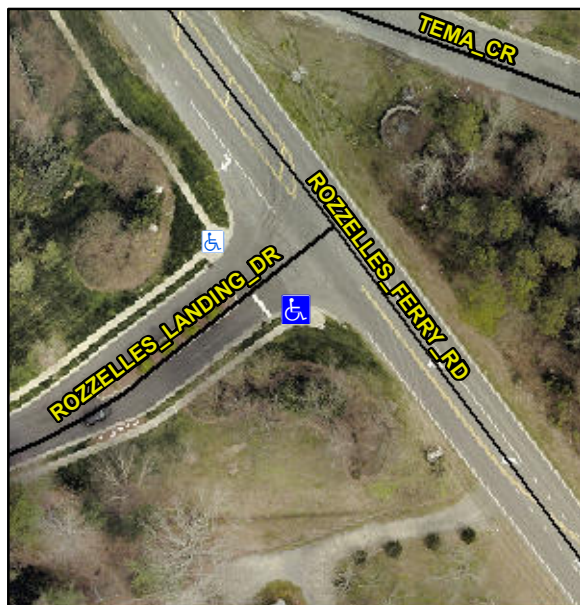
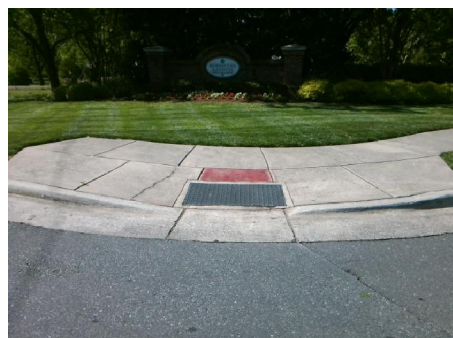
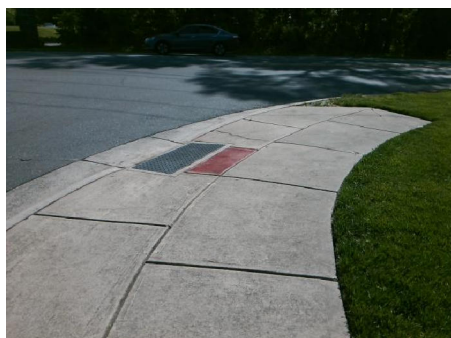
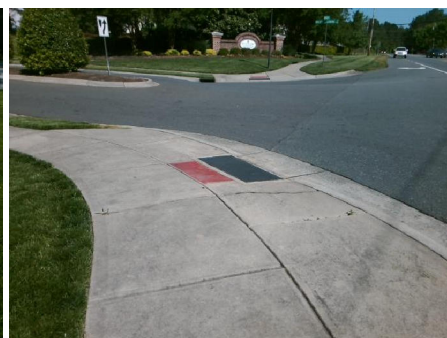
| Severity Score: 21.25 | | | |

R304.5.1, R304.2.2

| Compliance | Description | Data | Compliance | Description | Data |
|---|---|---|---|---|---|
| N/A | Ramp Length (in) | 49.0 | No | Ramp Slope (%) | 9.9 |
| No | Ramp Width (in) | 37.0 | Yes | Ramp XSlope (%) | 1.4 |

Remove & Replace Entire Ramp.
