# Access Compliance Report

## Public Rights-of-Way

### (Curb Ramps)

| Intersection ID: 9949 | Main Street: AVALON_AV | Cross Street: GLENWOOD_DR | Location: SW |

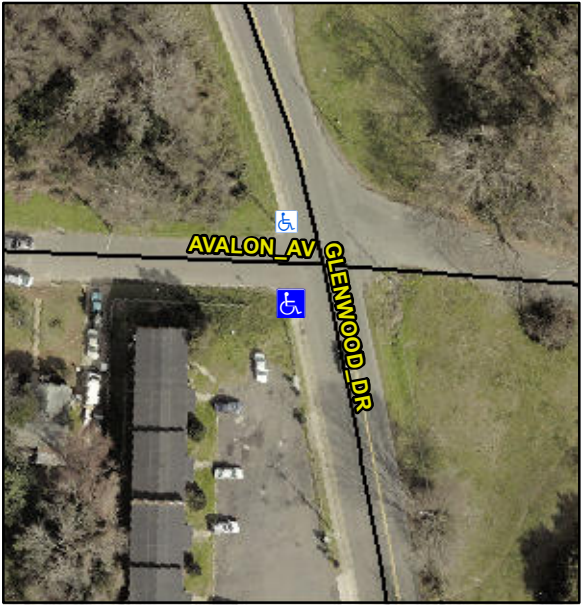
| ADA ID: 42E69976CA15 | Ramp Type: Perp | Initial Pass/Fail: Fail | Overall Compliance: No |
| | | Severity Score: 25 | |

| Codes/Mitigation Info/Possible Solution | | | Field Measurements/Component Compliance | | |
|---|---|--|---|---|---|
| <p>PROW/ADA:</p> <p><b>Not Found, R304.5.3</b></p> | | | <b>N/A</b> | Ramp inside XWalk2? | N/A |

| Codes/Mitigation Info/Possible Solution | | | Field Measurements/Component Compliance | | |
|---|---|--|---|---|---|
| | <b>Remove &amp; Replace Entire Ramp.</b> | | <b>Yes</b> | Ramp Length (in) | 50.0 |
| <p>Total Cost:</p> <p><b>\$ 1850.00</b></p> | | | <b>N/A</b> | Clear Space? | N/A |

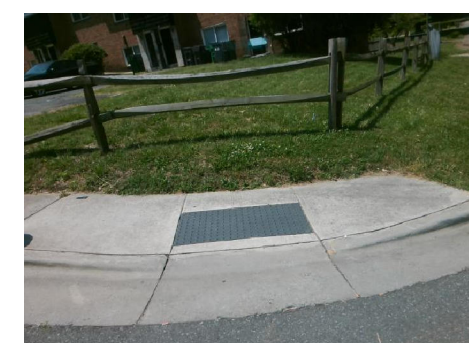
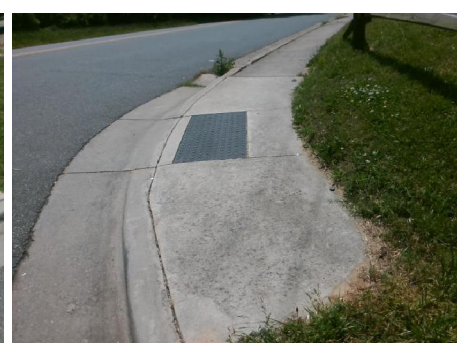
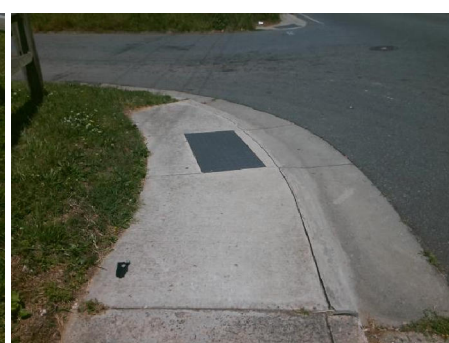
| Codes/Mitigation Info/Possible Solution | | | Field Measurements/Component Compliance | | |
|---|---|--|---|---|---|
| | | | <b>N/A</b> | X Walk 1 Slope (%) | 7.1 |
| | | | <b>N/A</b> | X Walk 1 X Slope (%) | 10.1 |
