Access Compliance Report

Public Rights-of-Way

(Curb Ramps)

Intersection ID: 3737	Main Street: CANTER_POST_DR	Cross Street: TROTTER_RD	Location:	W
ADA ID: 42EC6CC3716D	Ramp Type: Perp	Initial Pass/Fail: Fail	Overall Compliance: No	Severity Score: 37.5
Codes/Mitigation Info/Possible Solution		Field Measurements/Component Compliance

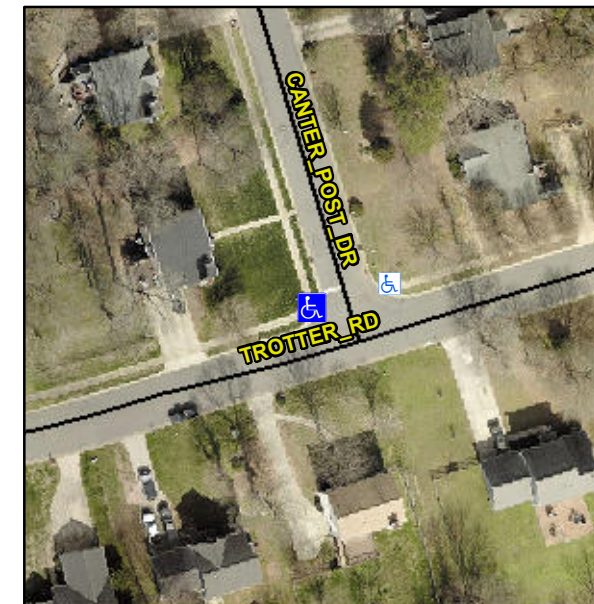
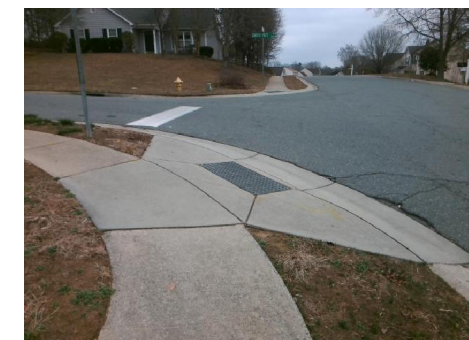
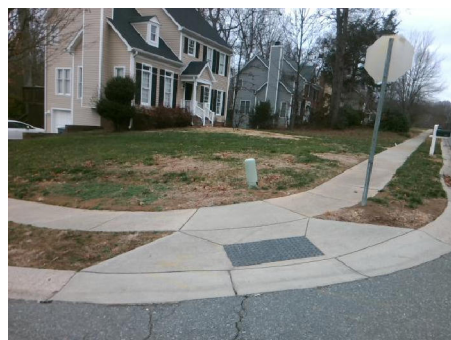
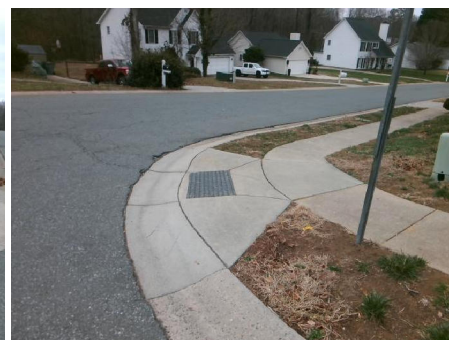
R304.2.2, R304.5.3

Compliance	Description	Data	Compliance	Description	Data
N/A	Ramp Length (in)	48.0	No	Ramp Slope (%)	9.7
Yes	Ramp Width (in)	48.0	No	Ramp XSlope (%)	12.3
N/A	Flare Type LT	N/A	N/A	Flare Type RT	N/A
N/A	Flare Slope LT (%)	N/A	N/A	Flare Slope RT (%)	N/A
N/A	Flare Traversable LT?	N/A	N/A	Flare Traversable RT?	N/A
N/A	Landing Length (in)	N/A	N/A	DWS Provided?	N/A
N/A	Landing Width (in)	N/A	N/A	DWS Contrast?	N/A
N/A	Landing Slope (%)	N/A	N/A	DWS Length (in)	N/A
N/A	Landing X Slope (%)	N/A	N/A	DWS Full Width?	N/A
N/A	Landing Curb? (Y/N)	N/A	N/A	DWS Offset (in)	N/A
N/A	Shared Landing?	N/A			
N/A	Gutter Ponding?	N/A	N/A	Gutter Slope (%)	N/A
N/A	Gutter Lip Ht (in)	N/A	N/A	Gutter X Slope (%)	N/A
N/A	Painted X Walk1?	No	N/A	Painted X Walk2?	N/A
	X Walk 1 Direction	To E		X Walk 2 Direction	N/A
N/A	X Walk 1 Width (in)	N/A	N/A	X Walk 2 Width (in)	N/A
	X Walk 1 Slope (%)	9.7		X Walk 2 Slope (%)	N/A
	X Walk 1 X Slope (%)	4.1		X Walk 2 X Slope (%)	N/A

Remove & Replace Entire Ramp.
