# Access Compliance Report

## Public Rights-of-Way

### (Curb Ramps)

Intersection ID: 15481	Main Street: HEMLOCK_ST	Cross Street: KENILWORTH_AV	Location: S
ADA ID: 42F90E1673EB	Ramp Type: PerpDiag	Initial Pass/Fail: Fail	Overall Compliance: No
		Severity Score: 10

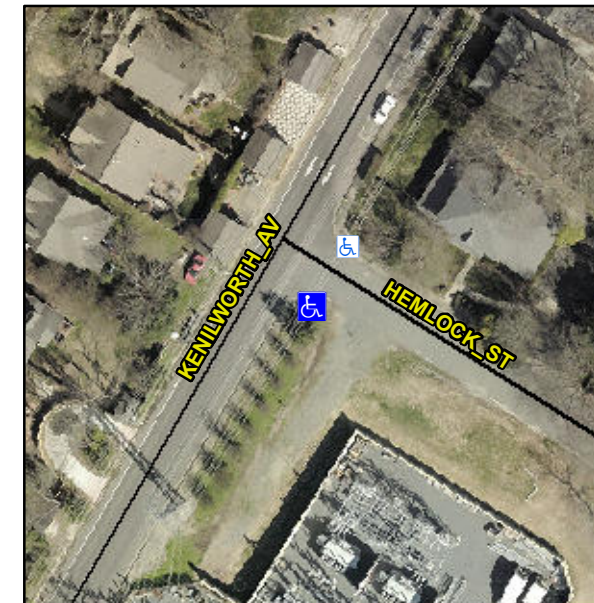
**Not Found, R304.5.1, R304.5.3**

Compliance	Description	Data	Compliance	Description	Data
N/A	Ramp Length (in)	34.0	Yes	Ramp Slope (%)	7.4
No	Ramp Width (in)	41.0	No	Ramp XSlope (%)	3.2
N/A	Flare Type LT	N/A	N/A	Flare Type RT	N/A
N/A	Flare Slope LT (%)	N/A	N/A	Flare Slope RT (%)	N/A
N/A	Flare Traversable LT?	N/A	N/A	Flare Traversable RT?	N/A
N/A	Landing Length (in)	N/A	N/A	DWS Provided?	N/A
N/A	Landing Width (in)	N/A	N/A	DWS Contrast?	N/A
N/A	Landing Slope (%)	N/A	N/A	DWS Length (in)	N/A
N/A	Landing X Slope (%)	N/A	N/A	DWS Full Width?	N/A
N/A	Landing Curb? (Y/N)	N/A	N/A	DWS Offset (in)	N/A
N/A	Shared Landing?	N/A			
N/A	Gutter Ponding?	N/A	N/A	Gutter Slope (%)	N/A
N/A	Gutter Lip Ht (in)	N/A	N/A	Gutter X Slope (%)	N/A
N/A	Painted X Walk1?	No	N/A	Painted X Walk2?	No
	X Walk 1 Direction	To NE		X Walk 2 Direction	To NW
N/A	X Walk 1 Width (in)	N/A	N/A	X Walk 2 Width (in)	N/A
	X Walk 1 Slope (%)	1.4		X Walk 2 Slope (%)	3.6
	X Walk 1 X Slope (%)	4.6		X Walk 2 X Slope (%)	0.9

N/A	Ramp inside XWalk1?	N/A	N/A	Ramp inside XWalk2?	N/A
	Road Slope (%)	2.4	N/A	Clear Space?	N/A
	Road X Slope (%)	5.0	N/A	Clear Space to XWalk (in)	N/A
N/A	Any Obstructions?	N/A	N/A	Storm Grate/Utility Hazard?	N/A
	Obstruction Type			Storm Grate/Utility Type	
		N/A			N/A
			Yes	Surface Condition? (G/P)	Good

Possible Solutions:

**Remove & Replace Curb Ramp With Two New Directional Ramps or Equivalent.**
