# Access Compliance Report

## Public Rights-of-Way

### (Curb Ramps)

Intersection ID: 10399	Main Street: E_35TH_ST	Cross Street: GARRISON_ST	Location: W
ADA ID: 4315DA190DB7	Ramp Type: Perp	Initial Pass/Fail: Fail	Overall Compliance: No
		Severity Score: 37.5

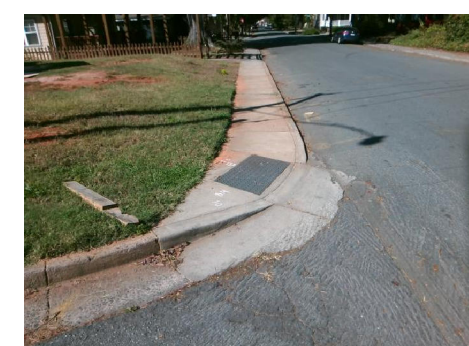
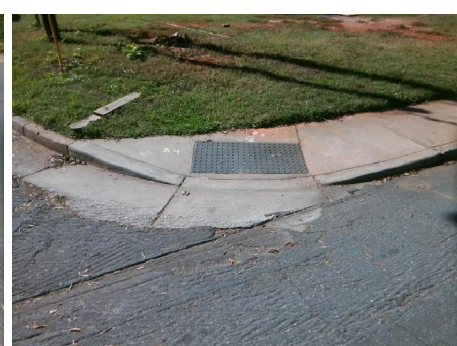
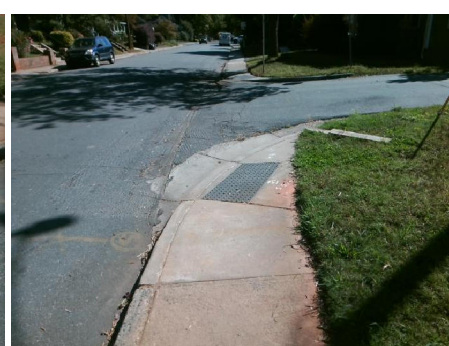
Possible Solutions:		<b>Compliance</b>	<b>Description</b>	<b>Data</b>
	<b>Remove &amp; Replace Entire Ramp.</b>		<b>No</b>	Ramp Length (in)	<b>34.5</b>
			<b>Yes</b>	Ramp Width (in)	<b>48.0</b>
			<b>N/A</b>	Flare Type LT	<b>N/A</b>
			<b>N/A</b>	Flare Slope LT (%)	<b>N/A</b>
			<b>N/A</b>	Flare Traversable LT?	<b>N/A</b>
			<b>N/A</b>	Landing Length (in)	<b>N/A</b>
			<b>N/A</b>	Landing Width (in)	<b>N/A</b>
			<b>N/A</b>	Landing Slope (%)	<b>N/A</b>
			<b>N/A</b>	Landing X Slope (%)	<b>N/A</b>
<p>Surveyor Notes:</p> <p><b>N/A</b></p> <p>PROW/ADA:</p> <p><b>Not Found, R304.2.2, R304.5.3</b></p>			<b>N/A</b>	Flare Type RT	<b>N/A</b>
			<b>N/A</b>	Flare Slope RT (%)	<b>N/A</b>
			<b>N/A</b>	Flare Traversable RT?	<b>N/A</b>
			<b>N/A</b>	DWS Provided?	<b>N/A</b>
			<b>N/A</b>	DWS Contrast?	<b>N/A</b>
			<b>N/A</b>	DWS Length (in)	<b>N/A</b>

<b>N/A</b>	DWS Full Width?	<b>N/A</b>
			<b>N/A</b>	DWS Offset (in)	<b>N/A</b>
			<b>N/A</b>	Gutter Ponding?	<b>N/A</b>
			<b>N/A</b>	Gutter Lip Ht (in)	<b>1.0</b>
			<b>No</b>	Painted X Walk1?	<b>N/A</b>
				X Walk 1 Direction	<b>To SE</b>
			<b>N/A</b>	X Walk 1 Width (in)	<b>N/A</b>
				X Walk 1 Slope (%)	<b>0.1</b>
				X Walk 1 X Slope (%)	<b>8.4</b>
			<b>N/A</b>	Ramp inside XWalk1?	<b>N/A</b>
			<b>N/A</b>	Road Slope (%)	<b>N/A</b>
			<b>N/A</b>	Road X Slope (%)	<b>N/A</b>
			<b>N/A</b>	Any Obstructions?	<b>N/A</b>
				Obstruction Type	
Total Cost: \$ 1850.00			<b>N/A</b>	Storm Grate/Utility Hazard?	<b>N/A</b>
				Storm Grate/Utility Type	
			<b>N/A</b>		<b>N/A</b>
			<b>Yes</b>	Surface Condition? (G/P)	<b>Good</b>
