Access Compliance Report Public Rights-of-Way (Curb Ramps)

Intersection ID: N/A Main Street: ASCENSION_WY **Cross Street: HORACE_ST** Location: NW **Severity Score: Overall Compliance: No ADA ID: 43194ECA4BED** Ramp Type: Perp Initial Pass/Fail: Fail 1.25

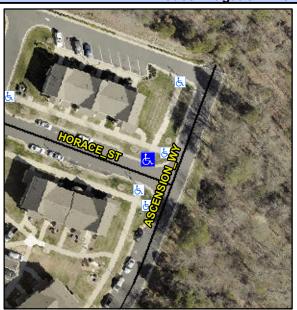
Field Measurements/Component Compliance								
Compl	iance Description	Data	Compl	iance	Description	Data		
N/A	Ramp Length (in)	72.0	Yes	Ramp	Slope (%)	7.1		
Yes	Ramp Width (in)	71.0	No	Ramp	XSlope (%)	2.8		
N/A	Flare Type LT	N/A	N/A	Flare	Type RT	N/A		
N/A	Flare Slope LT (%)	N/A	N/A	Flare Slope RT (%)		N/A		
N/A	Flare Traversable LT?	N/A	N/A	Flare	N/A			
N/A	Landing Length (in)	N/A	N/A	DWS	Provided?	N/A		
N/A	Landing Width (in)	N/A	N/A	DWS	Contrast?	N/A		
N/A	Landing Slope (%)	N/A	N/A	DWS	Length (in)	N/A		
N/A	Landing X Slope (%)	N/A	N/A	DWS	Full Width?	N/A		
N/A	Landing Curb? (Y/N)	N/A	N/A	DWS	Offset (in)	N/A		
N/A	Shared Landing?	N/A						
N/A	Gutter Ponding?	N/A	N/A	Gutte	r Slope (%)	N/A		
N/A	Gutter Lip Ht (in)	N/A	N/A	Gutte	r X Slope (%)	N/A		
N/A	Painted X Walk1?	No	N/A	Paint	ed X Walk2?	N/A		
	X Walk 1 Direction	To SW		X Wa	lk 2 Direction	N/A		
N/A	X Walk 1 Width (in)	N/A	N/A	X Wa	lk 2 Width (in)	N/A

X Walk 1 Slope (%)	1.4		X Wa	lk 2 Slope (%)	N/A		
	X Walk 1 X Slope (%)	3.5		X Wa	lk 2 X Slope (%)	N/A		
N/A	Ramp inside XWalk1?	N/A	N/A	Ramp	inside XWalk2?	N/A		
	Road Slope (%)	N/A	N/A	Clear	Space?	N/A		
	Road X Slope (%)	N/A	N/A	Clear	Space to XWalk (in)	N/A		
N/A	Any Obstructions?	N/A	N/A	Storm	Grate/Utility Hazard?	N/A		
	Obstruction Type			Storm	Grate/Utility Type			
		N/A				N/A		
			Yes	Surfa	ce Condition? (G/P)	Good

71 OSSIDIE GOIGLIOIT	
Possible Solutions:	Co
Remove & Replace Entire Ramp.	N/
	Ye
	N/A
	N/
	N/
	N/
Surveyor Notes:	N/
N/A	N/
	N/
	N/
	N/
PROW/ADA:	N/
Not Found, R304.5.3	N/A
	N/
	N/
