Intersection ID: 7355 Main Street: HIDDEN FOREST DR **Cross Street: PONDELLA DR** Location: SW Initial Pass/Fail: Fail **Overall Compliance: No** ADA ID: 43340B2C50B4 Ramp Type: Combination1 **Severity Score:** 47.5

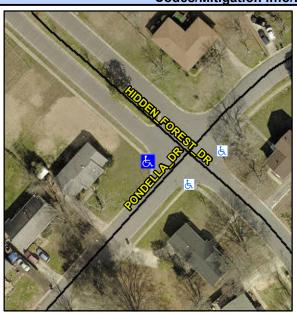
Street 1 Name StopSign **PONDELLA DR** Stop Condition-Street 1 N/A Street 2 Name Stop Condition-Street 2 N/A Possible Solutions: Remove & Replace Entire Ramp. Surveyor Notes: LT RP < 5%, RT RP < 5% PROW/ADA: Not Found, R304.5.1, R304.5.1, R304.5.3
