Intersection ID: 10016063	Main Street: N_TRYON_ST	Cross Street: N/A	Location:	SW
ADA ID: 433A32CFC267	Ramp Type: PerpDiag	Initial Pass/Fail: Fail	Overall Compliance: No	Severity Score: 12.5

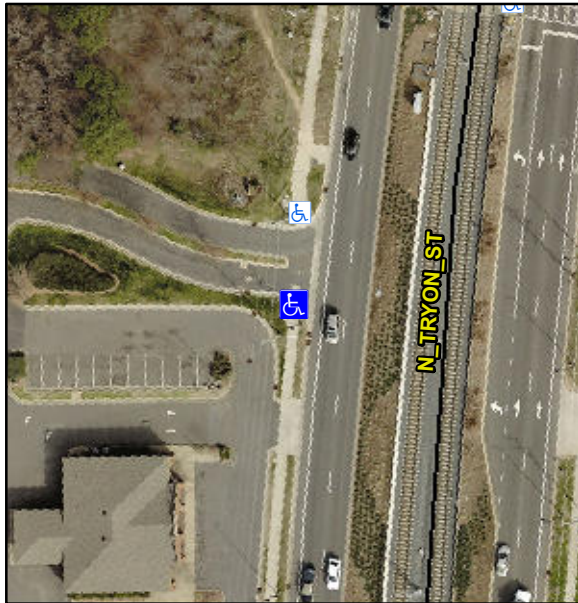
R304.5.3

Compliance	Description	Data	Compliance	Description	Data
N/A	Ramp Length (in)	46.0	Yes	Ramp Slope (%)	6.6
Yes	Ramp Width (in)	48.0	No	Ramp XSlope (%)	6.1
N/A	Flare Type LT	N/A	N/A	Flare Type RT	N/A
N/A	Flare Slope LT (%)	N/A	N/A	Flare Slope RT (%)	N/A
N/A	Flare Traversable LT?	N/A	N/A	Flare Traversable RT?	N/A
N/A	Landing Length (in)	N/A	N/A	DWS Provided?	N/A
N/A	Landing Width (in)	N/A	N/A	DWS Contrast?	N/A
N/A	Landing Slope (%)	N/A	N/A	DWS Length (in)	N/A
N/A	Landing X Slope (%)	N/A	N/A	DWS Full Width?	N/A
N/A	Landing Curb? (Y/N)	N/A	N/A	DWS Offset (in)	N/A
N/A	Shared Landing?	N/A			
N/A	Gutter Ponding?	N/A	N/A	Gutter Slope (%)	N/A
N/A	Gutter Lip Ht (in)	N/A	N/A	Gutter X Slope (%)	N/A
N/A	Painted X Walk1?	No	N/A	Painted X Walk2?	No
	X Walk 1 Direction	To E		X Walk 2 Direction	To N
N/A	X Walk 1 Width (in)	N/A	N/A	X Walk 2 Width (in)	N/A
	X Walk 1 Slope (%)	1.4		X Walk 2 Slope (%)	2.6
	X Walk 1 X Slope (%)	1.6		X Walk 2 X Slope (%)	1.4

N/A	Ramp inside XWalk1?	N/A	N/A	Ramp inside XWalk2?	N/A
	Road Slope (%)	1.9	N/A	Clear Space?	N/A
	Road X Slope (%)	1.2	N/A	Clear Space to XWalk (in)	N/A
N/A	Any Obstructions?	N/A	N/A	Storm Grate/Utility Hazard?	N/A
	Obstruction Type			Storm Grate/Utility Type	
		N/A			N/A
			Yes	Surface Condition? (G/P)	Good

Remove & Replace Curb Ramp With Two New Directional Ramps or Equivalent.

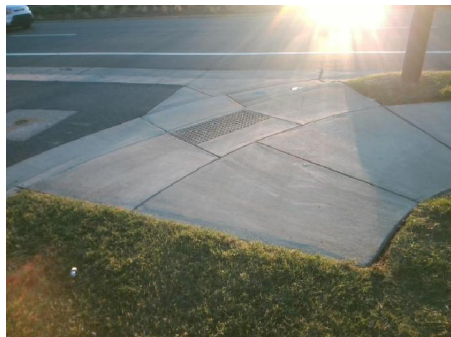
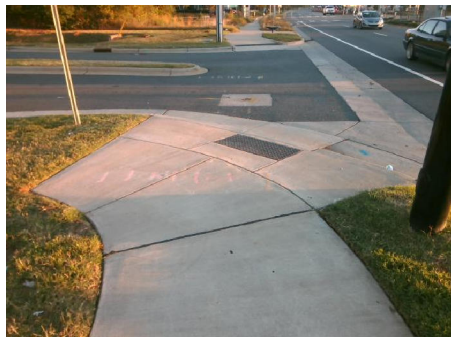
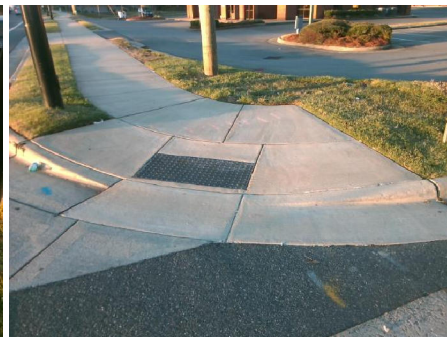
Street 1 Name	N TRYON ST
Stop Condition-Street 2	None
Street 2 Name	ENTRANCE
Stop Condition-Street 1	StopSign
