# Access Compliance Report

## Public Rights-of-Way

### (Curb Ramps)

Intersection ID: 15813	Main Street: QUEENS_RD_WEST	Cross Street: ROLSTON_DR	Location:	N
ADA ID: 4341238FF88D	Ramp Type: MedianPerp	Initial Pass/Fail: Fail	Overall Compliance: No	Severity Score: 12.5
Codes/Mitigation Info/Possible Solution		Field Measurements/Component Compliance

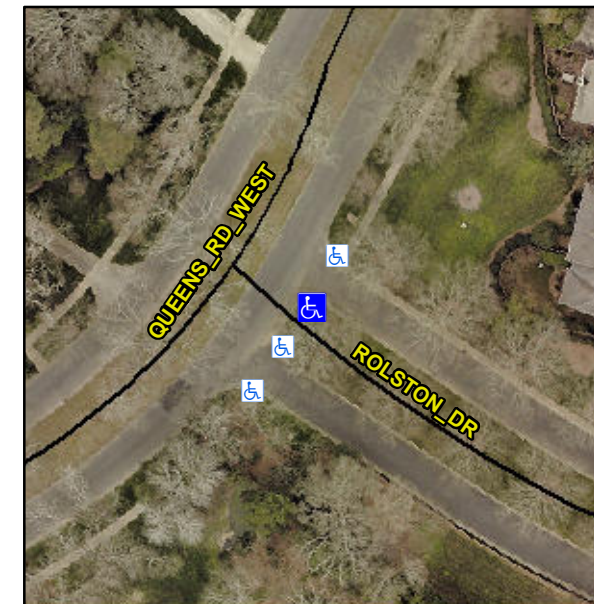
**Not Found, R304.5.3**

Compliance	Description	Data	Compliance	Description	Data
N/A	Ramp Length (in)	36.0	Yes	Ramp Slope (%)	5.2
Yes	Ramp Width (in)	48.0	No	Ramp XSlope (%)	5.6
N/A	Flare Type LT	N/A	N/A	Flare Type RT	N/A
N/A	Flare Slope LT (%)	N/A	N/A	Flare Slope RT (%)	N/A
N/A	Flare Traversable LT?	N/A	N/A	Flare Traversable RT?	N/A
N/A	Landing Length (in)	N/A	N/A	DWS Provided?	N/A
N/A	Landing Width (in)	N/A	N/A	DWS Contrast?	N/A
N/A	Landing Slope (%)	N/A	N/A	DWS Length (in)	N/A
N/A	Landing X Slope (%)	N/A	N/A	DWS Full Width?	N/A
N/A	Landing Curb? (Y/N)	N/A	N/A	DWS Offset (in)	N/A
N/A	Shared Landing?	N/A			
N/A	Gutter Ponding?	N/A	N/A	Gutter Slope (%)	N/A
N/A	Gutter Lip Ht (in)	N/A	N/A	Gutter X Slope (%)	N/A
N/A	Painted X Walk1?	No	N/A	Painted X Walk2?	N/A
	X Walk 1 Direction	To NE		X Walk 2 Direction	N/A
N/A	X Walk 1 Width (in)	N/A	N/A	X Walk 2 Width (in)	N/A
	X Walk 1 Slope (%)	1.4		X Walk 2 Slope (%)	N/A
	X Walk 1 X Slope (%)	3.4		X Walk 2 X Slope (%)	N/A

N/A	Ramp inside XWalk1?	N/A	N/A	Ramp inside XWalk2?	N/A
	Road Slope (%)	N/A	N/A	Clear Space?	N/A
	Road X Slope (%)	N/A	N/A	Clear Space to XWalk (in)	N/A
N/A	Any Obstructions?	N/A	N/A	Storm Grate/Utility Hazard?	N/A
	Obstruction Type			Storm Grate/Utility Type	
		N/A			N/A
			Yes	Surface Condition? (G/P)	Good

Possible Solutions:

**Remove & Replace Entire Ramp.**

Total Cost: \$ 1650.00
