# Access Compliance Report

## Public Rights-of-Way

### (Curb Ramps)

Intersection ID: 29979	Main Street: REIGATE_RD	Cross Street: ALBANS_LN	Location: SE
ADA ID: 435743515757	Ramp Type: PerpDiag	Initial Pass/Fail: Fail	Overall Compliance: No
Severity Score: 10			
Codes/Mitigation Info/Possible Solution		Field Measurements/Component Compliance

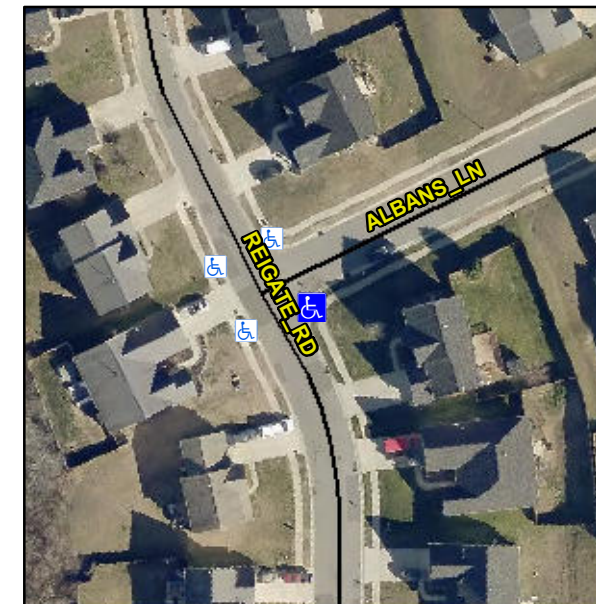
Compliance	Description	Data	Compliance	Description	Data
N/A	Ramp Length (in)	45.0	Yes	Ramp Slope (%)	7.8
No	Ramp Width (in)	36.0	No	Ramp XSlope (%)	3.3
N/A	Flare Type LT	N/A	N/A	Flare Type RT	N/A
N/A	Flare Slope LT (%)	N/A	N/A	Flare Slope RT (%)	N/A
N/A	Flare Traversable LT?	N/A	N/A	Flare Traversable RT?	N/A
N/A	Landing Length (in)	N/A	N/A	DWS Provided?	N/A
N/A	Landing Width (in)	N/A	N/A	DWS Contrast?	N/A
N/A	Landing Slope (%)	N/A	N/A	DWS Length (in)	N/A
N/A	Landing X Slope (%)	N/A	N/A	DWS Full Width?	N/A
N/A	Landing Curb? (Y/N)	N/A	N/A	DWS Offset (in)	N/A
N/A	Shared Landing?	N/A			
N/A	Gutter Ponding?	N/A	N/A	Gutter Slope (%)	N/A
N/A	Gutter Lip Ht (in)	N/A	N/A	Gutter X Slope (%)	N/A
N/A	Painted X Walk1?	No	N/A	Painted X Walk2?	No
	X Walk 1 Direction	To N		X Walk 2 Direction	To W
N/A	X Walk 1 Width (in)	N/A	N/A	X Walk 2 Width (in)	N/A
	X Walk 1 Slope (%)	1.4		X Walk 2 Slope (%)	2.0
	X Walk 1 X Slope (%)	0.5		X Walk 2 X Slope (%)	1.9

N/A	Ramp inside XWalk1?	N/A	N/A	Ramp inside XWalk2?	N/A
	Road Slope (%)	1.9	N/A	Clear Space?	N/A
	Road X Slope (%)	1.6	N/A	Clear Space to XWalk (in)	N/A
N/A	Any Obstructions?	N/A	N/A	Storm Grate/Utility Hazard?	N/A
	Obstruction Type			Storm Grate/Utility Type	
		N/A			N/A
		Yes		Surface Condition? (G/P)	Good

**Remove & Replace Curb Ramp With Two New Directional Ramps or Equivalent.**

**R304.5.1, R304.5.3**
