# Access Compliance Report

## Public Rights-of-Way

### (Curb Ramps)

Intersection ID: 4079	Main Street: DENMEADE_DR	Cross Street: EDGEPIKE_DR	Location: SW
ADA ID: 4359BA805D58	Ramp Type: Perp	Initial Pass/Fail: Fail	Overall Compliance: No
Severity Score: 46.25			
Codes/Mitigation Info/Possible Solution		Field Measurements/Component Compliance

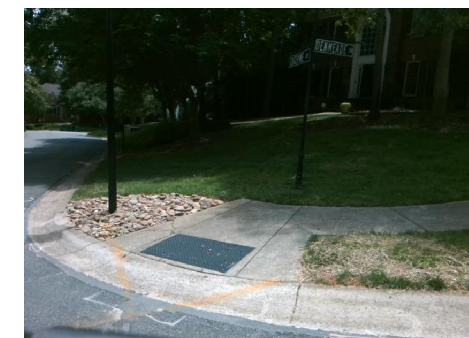
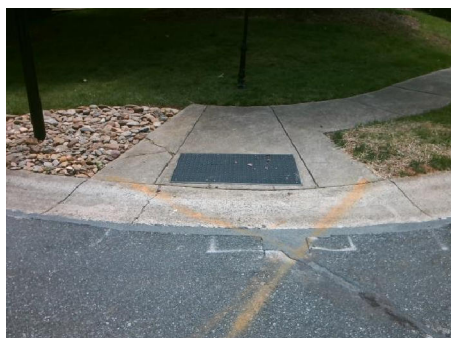
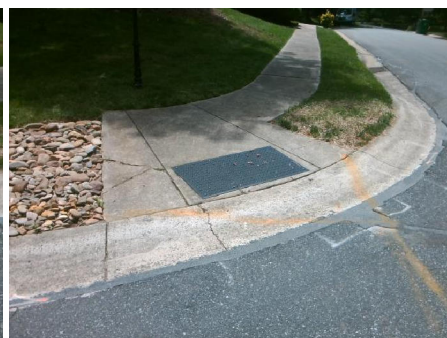
Compliance	Description	Data	Compliance	Description	Data
N/A	Ramp Length (in)	96.5	No	Ramp Slope (%)	11.4
No	Ramp Width (in)	36.0	No	Ramp XSlope (%)	7.7
N/A	Flare Type LT	N/A	N/A	Flare Type RT	N/A
N/A	Flare Slope LT (%)	N/A	N/A	Flare Slope RT (%)	N/A
N/A	Flare Traversable LT?	N/A	N/A	Flare Traversable RT?	N/A
N/A	Landing Length (in)	N/A	N/A	DWS Provided?	N/A
N/A	Landing Width (in)	N/A	N/A	DWS Contrast?	N/A
N/A	Landing Slope (%)	N/A	N/A	DWS Length (in)	N/A
N/A	Landing X Slope (%)	N/A	N/A	DWS Full Width?	N/A
N/A	Landing Curb? (Y/N)	N/A	N/A	DWS Offset (in)	N/A
N/A	Shared Landing?	N/A			
N/A	Gutter Ponding?	N/A	N/A	Gutter Slope (%)	N/A
N/A	Gutter Lip Ht (in)	N/A	N/A	Gutter X Slope (%)	N/A
N/A	Painted X Walk1?	No	N/A	Painted X Walk2?	N/A
	X Walk 1 Direction	To E		X Walk 2 Direction	N/A
N/A	X Walk 1 Width (in)	N/A	N/A	X Walk 2 Width (in)	N/A
	X Walk 1 Slope (%)	5.6		X Walk 2 Slope (%)	N/A
	X Walk 1 X Slope (%)	5.1		X Walk 2 X Slope (%)	N/A

N/A	Ramp inside XWalk1?	N/A	N/A	Ramp inside XWalk2?	N/A
	Road Slope (%)	N/A	N/A	Clear Space?	N/A
	Road X Slope (%)	N/A	N/A	Clear Space to XWalk (in)	N/A
N/A	Any Obstructions?	N/A	N/A	Storm Grate/Utility Hazard?	N/A
	Obstruction Type			Storm Grate/Utility Type	
		N/A			N/A
			Yes	Surface Condition? (G/P)	Good

**Remove & Replace Entire Ramp.**
