Access Compliance Report

Public Rights-of-Way

(Curb Ramps)

Intersection ID: 12364	Main Street: W_1ST_ST	Cross Street: S_MINT_ST	Location: S
ADA ID: 435FEB8A2362	Ramp Type: Perp	Initial Pass/Fail: Fail	Overall Compliance: No
			Severity Score: 21.25

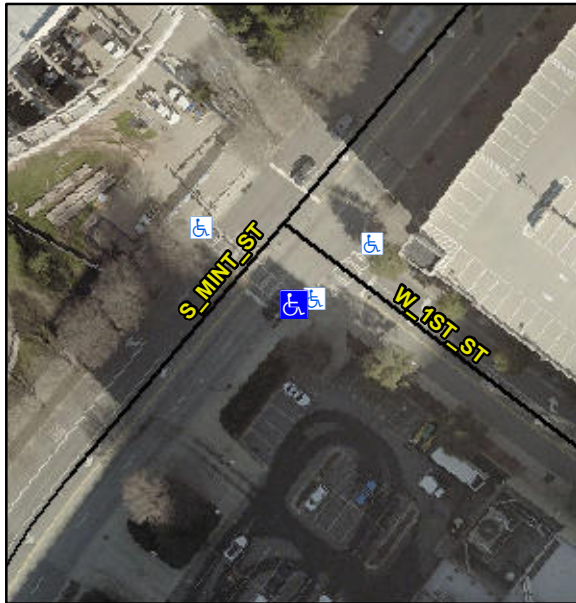
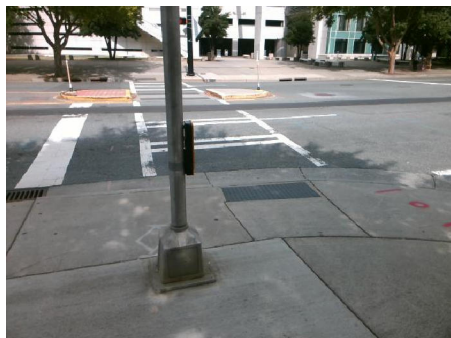
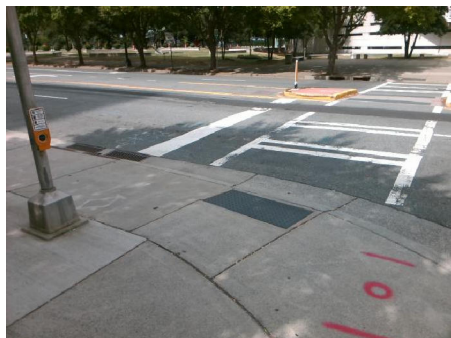
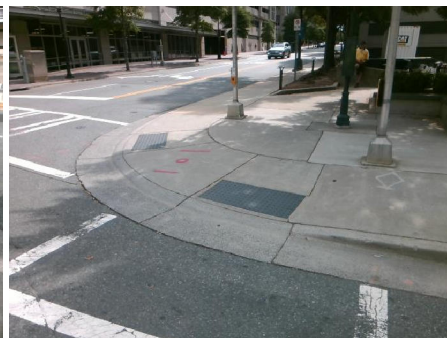
Not Found, R304.5.1, R304.2.2

Compliance	Description	Data	Compliance	Description	Data
N/A	Ramp Length (in)	70.0	No	Ramp Slope (%)	10.5
No	Ramp Width (in)	45.0	Yes	Ramp XSlope (%)	0.1
N/A	Flare Type LT	N/A	N/A	Flare Type RT	N/A
N/A	Flare Slope LT (%)	N/A	N/A	Flare Slope RT (%)	N/A
N/A	Flare Traversable LT?	N/A	N/A	Flare Traversable RT?	N/A
N/A	Landing Length (in)	N/A	N/A	DWS Provided?	N/A
N/A	Landing Width (in)	N/A	N/A	DWS Contrast?	N/A
N/A	Landing Slope (%)	N/A	N/A	DWS Length (in)	N/A
N/A	Landing X Slope (%)	N/A	N/A	DWS Full Width?	N/A
N/A	Landing Curb? (Y/N)	N/A	N/A	DWS Offset (in)	N/A
N/A	Shared Landing?	N/A			
N/A	Gutter Ponding?	N/A	N/A	Gutter Slope (%)	N/A
N/A	Gutter Lip Ht (in)	N/A	N/A	Gutter X Slope (%)	N/A
N/A	Painted X Walk1?	Yes	N/A	Painted X Walk2?	N/A
	X Walk 1 Direction	To NW		X Walk 2 Direction	N/A
N/A	X Walk 1 Width (in)	109.0	N/A	X Walk 2 Width (in)	N/A
	X Walk 1 Slope (%)	5.3		X Walk 2 Slope (%)	N/A
	X Walk 1 X Slope (%)	0.3		X Walk 2 X Slope (%)	N/A

N/A	Ramp inside XWalk1?	Yes	N/A	Ramp inside XWalk2?	N/A
	Road Slope (%)	N/A	N/A	Clear Space?	N/A
	Road X Slope (%)	N/A	N/A	Clear Space to XWalk (in)	N/A
N/A	Any Obstructions?	N/A	N/A	Storm Grate/Utility Hazard?	N/A
	Obstruction Type			Storm Grate/Utility Type	
		N/A			N/A
			Yes	Surface Condition? (G/P)	Good

Remove & Replace Entire Ramp.
