# Access Compliance Report

## Public Rights-of-Way

### (Curb Ramps)

Intersection ID: 27397	Main Street: ELM_LN	Cross Street: BALLANTYNE_COMMONS_PY	Location: SW
ADA ID: 4365A8390410	Ramp Type: Perp	Initial Pass/Fail: Fail	Overall Compliance: No
Codes/Mitigation Info/Possible Solution		Field Measurements/Component Compliance	
Severity Score: 22.5

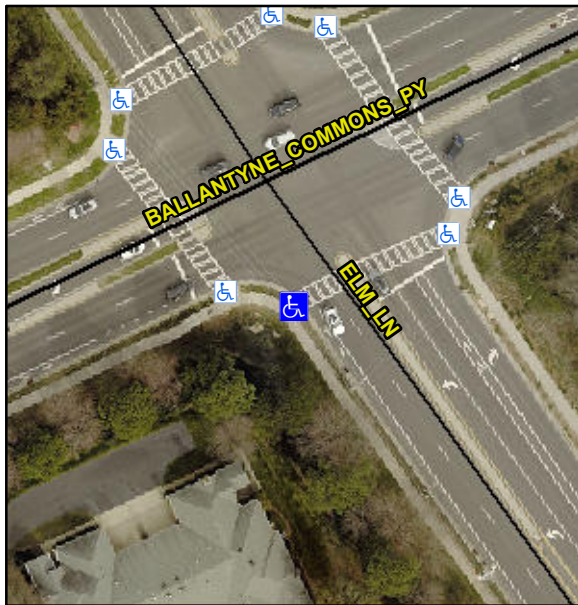
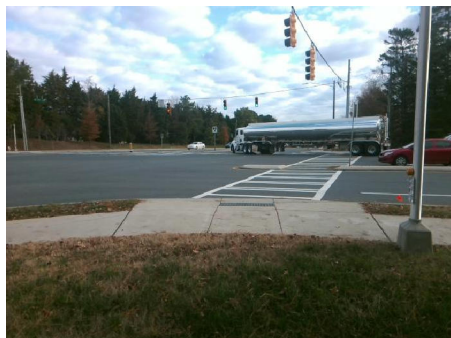
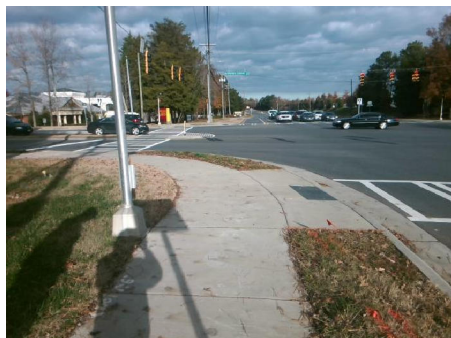
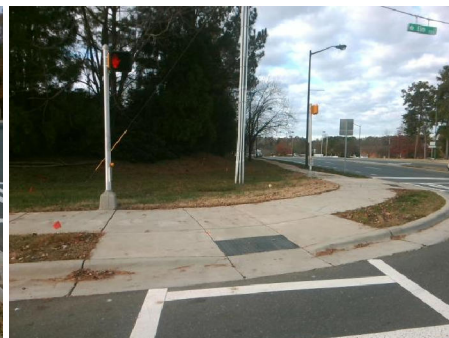
**Not Found, R304.5.1, R304.2.2, R304.5.3**

Compliance	Description	Data	Compliance	Description	Data
N/A	Ramp Length (in)	47.0	No	Ramp Slope (%)	8.9
No	Ramp Width (in)	45.5	No	Ramp XSlope (%)	2.9
N/A	Flare Type LT	N/A	N/A	Flare Type RT	N/A
N/A	Flare Slope LT (%)	N/A	N/A	Flare Slope RT (%)	N/A
N/A	Flare Traversable LT?	N/A	N/A	Flare Traversable RT?	N/A
N/A	Landing Length (in)	N/A	N/A	DWS Provided?	N/A
N/A	Landing Width (in)	N/A	N/A	DWS Contrast?	N/A
N/A	Landing Slope (%)	N/A	N/A	DWS Length (in)	N/A
N/A	Landing X Slope (%)	N/A	N/A	DWS Full Width?	N/A
N/A	Landing Curb? (Y/N)	N/A	N/A	DWS Offset (in)	N/A
N/A	Shared Landing?	N/A			
N/A	Gutter Ponding?	N/A	N/A	Gutter Slope (%)	N/A
N/A	Gutter Lip Ht (in)	N/A	N/A	Gutter X Slope (%)	N/A
N/A	Painted X Walk1?	Yes	N/A	Painted X Walk2?	N/A
	X Walk 1 Direction	To NE		X Walk 2 Direction	N/A
N/A	X Walk 1 Width (in)	106.0	N/A	X Walk 2 Width (in)	N/A
	X Walk 1 Slope (%)	1.7		X Walk 2 Slope (%)	N/A
	X Walk 1 X Slope (%)	0.9		X Walk 2 X Slope (%)	N/A

N/A	Ramp inside XWalk1?	Yes	N/A	Ramp inside XWalk2?	N/A
	Road Slope (%)	N/A	N/A	Clear Space?	N/A
	Road X Slope (%)	N/A	N/A	Clear Space to XWalk (in)	N/A
N/A	Any Obstructions?	N/A	N/A	Storm Grate/Utility Hazard?	N/A
	Obstruction Type			Storm Grate/Utility Type	
		N/A			N/A
			Yes	Surface Condition? (G/P)	Good

**Remove & Replace Entire Ramp.**
