# Access Compliance Report

## Public Rights-of-Way

### (Curb Ramps)

Intersection ID: 15013	Main Street: E_WORTHINGTON_AV	Cross Street: EWING_AV	Location: W
ADA ID: 43732577D187	Ramp Type: Perp	Initial Pass/Fail: Fail	Overall Compliance: No
Severity Score: 22.5			
Codes/Mitigation Info/Possible Solution		Field Measurements/Component Compliance

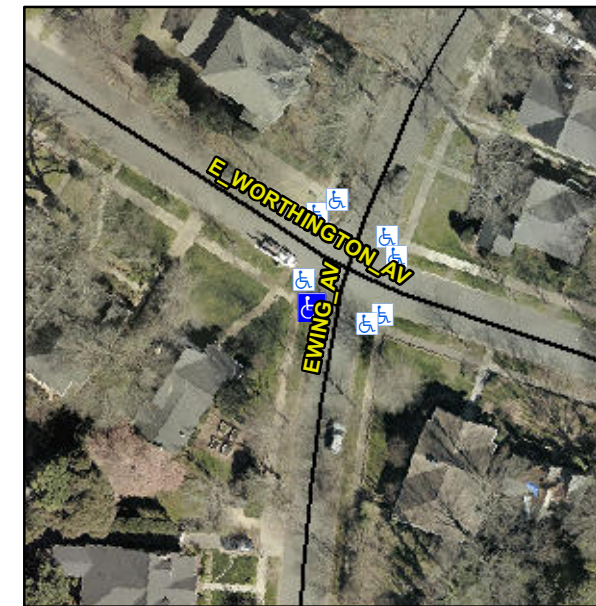
**Not Found, R304.5.1, R304.2.2, R304.5.3**

Compliance	Description	Data	Compliance	Description	Data
N/A	Ramp Length (in)	76.0	No	Ramp Slope (%)	9.4
No	Ramp Width (in)	36.0	No	Ramp XSlope (%)	4.1
N/A	Flare Type LT	N/A	N/A	Flare Type RT	N/A
N/A	Flare Slope LT (%)	N/A	N/A	Flare Slope RT (%)	N/A
N/A	Flare Traversable LT?	N/A	N/A	Flare Traversable RT?	N/A
N/A	Landing Length (in)	N/A	N/A	DWS Provided?	N/A
N/A	Landing Width (in)	N/A	N/A	DWS Contrast?	N/A
N/A	Landing Slope (%)	N/A	N/A	DWS Length (in)	N/A
N/A	Landing X Slope (%)	N/A	N/A	DWS Full Width?	N/A
N/A	Landing Curb? (Y/N)	N/A	N/A	DWS Offset (in)	N/A
N/A	Shared Landing?	N/A			
N/A	Gutter Ponding?	N/A	N/A	Gutter Slope (%)	N/A
N/A	Gutter Lip Ht (in)	N/A	N/A	Gutter X Slope (%)	N/A
N/A	Painted X Walk1?	No	N/A	Painted X Walk2?	N/A
	X Walk 1 Direction	To SE		X Walk 2 Direction	N/A
N/A	X Walk 1 Width (in)	N/A	N/A	X Walk 2 Width (in)	N/A
	X Walk 1 Slope (%)	0.5		X Walk 2 Slope (%)	N/A
	X Walk 1 X Slope (%)	2.3		X Walk 2 X Slope (%)	N/A

N/A	Ramp inside XWalk1?	N/A	N/A	Ramp inside XWalk2?	N/A
	Road Slope (%)	N/A	N/A	Clear Space?	N/A
	Road X Slope (%)	N/A	N/A	Clear Space to XWalk (in)	N/A
N/A	Any Obstructions?	N/A	N/A	Storm Grate/Utility Hazard?	N/A
	Obstruction Type			Storm Grate/Utility Type	
		N/A			N/A
			Yes	Surface Condition? (G/P)	Good

Possible Solutions:

**Remove & Replace Entire Ramp.**
