# Access Compliance Report

## Public Rights-of-Way

### (Curb Ramps)

Intersection ID: 17486		Main Street: SELWYN_AV		Cross Street: STERLING_RD		Location: NW											
ADA ID: 43792DCD2209		Ramp Type: Directional1		Initial Pass/Fail: Fail		Overall Compliance: No		Severity Score: 25									
Codes/Mitigation Info/Possible Solution				Field Measurements/Component Compliance													
<div>

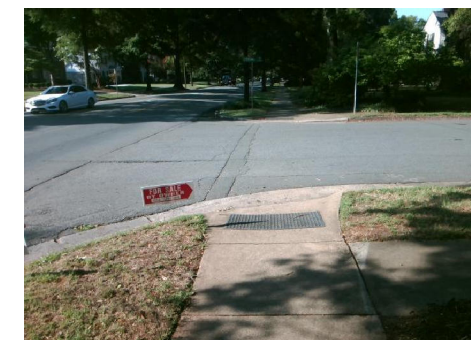
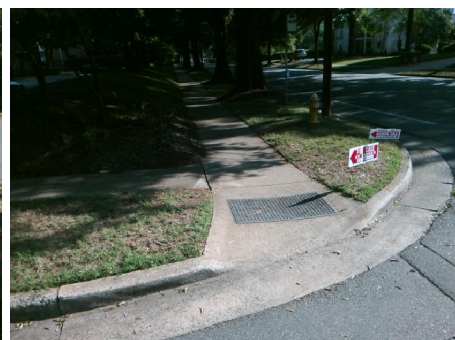
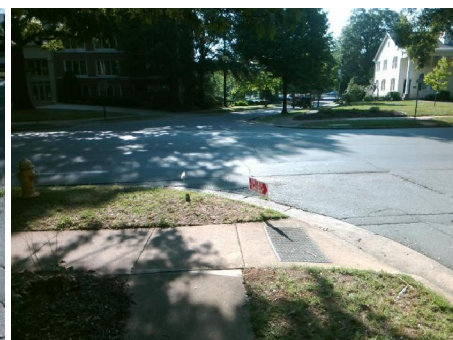
Yes		Ramp Slope (%)		8.2		N/A		Grade Break XSlope (%)		0.0			
				No		Ramp XSlope (%)		8.0									
				N/A		Flare Type LT		N/A		N/A		Flare Type RT		N/A			
				N/A		Flare Slope LT (%)		N/A		N/A		Flare Slope RT (%)		0.0			
				N/A		Flare Traversable LT?		N/A		N/A		Flare Traversable RT?		N/A			
				N/A		Landing Length (in)		0.0		N/A		DWS Provided?		N/A			
				N/A		Landing Width (in)		0.0		N/A		DWS Contrast?		N/A			
				N/A		Landing Slope (%)		0.0		N/A		DWS Length (in)		N/A			
				N/A		Landing X Slope (%)		0.0		N/A		DWS Full Width?		N/A			
				N/A		Landing Curb? (Y/N)		N/A		N/A		DWS Offset LT (in)		N/A			
				N/A		Shared Landing?		N/A		N/A		DWS Offset RT (in)		N/A			
				N/A		Gutter Ponding?		0.0		N/A		Gutter Slope (%)		N/A			
				N/A		Gutter Lip Ht (in)		0.0		N/A		Gutter X Slope (%)		N/A			
				N/A		Painted X Walk1?		No				Road Slope (%)		3.5			
						X Walk 1 Direction		To S				Road X Slope (%)		1.7

X Walk 1 Width (in)		N/A				Clear Space?		N/A			
						X Walk 1 Slope (%)		3.5		N/A		Clear Space to XWalk (in)		N/A			
						X Walk 1 X Slope (%)		1.7		N/A		Storm Grate/Utility Hazard?		N/A			
				N/A		Ramp inside XWalk1?		N/A				Storm Grate/Utility Type					
				N/A		Any Obstructions?		N/A						N/A			
						Obstruction Type				Yes		Surface Condition? (G/P)		Good			
										N/A		N/A		Curb Slope (%)		22.5

</div> <div>Possible Solutions:</div> <div>Remove &amp; Replace Entire Ramp.</div> <div>Surveyor Notes:</div> <div>N/A</div> <div>PROW/ADA:</div> <div>R304.5.3</div> <div>Street 1 Name</div> <div>STERLING RD</div> <div>Stop Condition-Street 1</div> <div>StopSign</div> <div>Street 2 Name</div> <div>N/A</div> <div>Stop Condition-Street 2</div> <div>N/A</div> <div>Total Cost:</div> <div>\$</div> <div>1600.00</div>				Compliance		Description		Data		Compliance		Description		Data			
				N/A		Ramp Length (in)		41.0		N/A		Grade Break?		N/A			
				Yes		Ramp Width (in)		61.0		N/A		Grade Break Slope (%)		0.0
