Access Compliance Report Public Rights-of-Way (Curb Ramps)

Intersection ID: 11318 Main Street: GRANDIN_RD Cross Street: W_4TH_ST_EXT Location: NE

ADA ID: 43881B150982 Ramp Type: Perp Initial Pass/Fail: Pass Overall Compliance: Yes Severity Score: 0

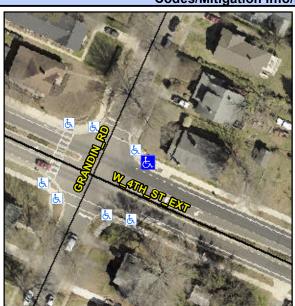
N/A	Ramp Length (in)	48.0	Yes	Ramp Slope (%)	7.6
Yes	Ramp Width (in)	70.0	Yes	Ramp XSlope (%)	1.6
Yes	Flare Type L Curbed_NoWalkSurface		Yes	Flare Type RT	N/A
Yes	Flare Slope LT (%)	N/A	N/A	Flare Slope RT (%)	N/A
N/A	Flare Traversable LT?	No	N/A	Flare Traversable RT?	No
Yes	Landing Length (in)	71.0	Yes	DWS Provided?	Yes
Yes	Landing Width (in)	70.0	Yes	DWS Contrast?	Yes
Yes	Landing Slope (%)	0.5	Yes	DWS Length (in)	24.0
Yes	Landing X Slope (%)	1.5	Yes	DWS Full Width?	Yes
N/A	Landing Curb? (Y/N)	No	Yes	DWS Offset (in)	0.0
N/A	Shared Landing?	No			
Yes	Gutter Ponding?	No	Yes	Gutter Slope (%)	1.4
Yes	Gutter Lip Ht (in)	0.0	Yes	Gutter X Slope (%)	2.4
N/A	Painted X Walk1?	No	N/A	Painted X Walk2?	N/A
	X Walk 1 Direction	To SW		X Walk 2 Direction	N/A
N/A	X Walk 1 Width (in)	N/A	N/A	X Walk 2 Width (in)	N/A
	X Walk 1 Slope (%)	0.8		X Walk 2 Slope (%)	N/A
	X Walk 1 X Slope (%)	3.0		X Walk 2 X Slope (%)	N/A
N/A	Ramp inside XWalk1?	N/A	N/A	Ramp inside XWalk2?	N/A

Road Slope (%)	N/A	N/A	Clear Space?	Yes
	Road X Slope (%)	N/A	N/A	Clear Space to XWalk (in)	N/A
Yes	Any Obstructions?	No	Yes	Storm Grate/Utility Hazard?	No
	Obstruction Type			Storm Grate/Utility Type	
		N/A			N/A
