# Access Compliance Report

## Public Rights-of-Way

### (Curb Ramps)

| Intersection ID: 49920 | Main Street: AUSTIN_DEKOTA_DR | Cross Street: WANAMASSA_DR | Location: W |

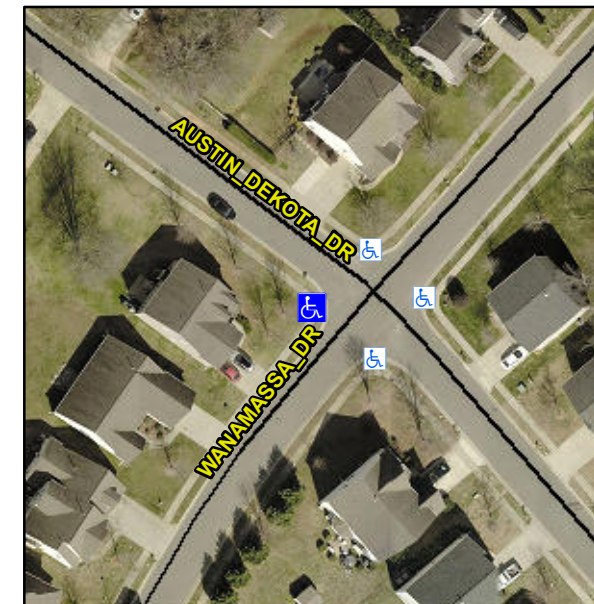
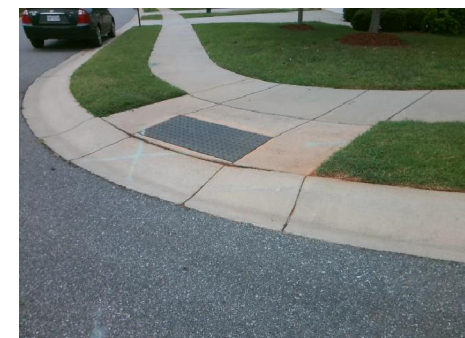
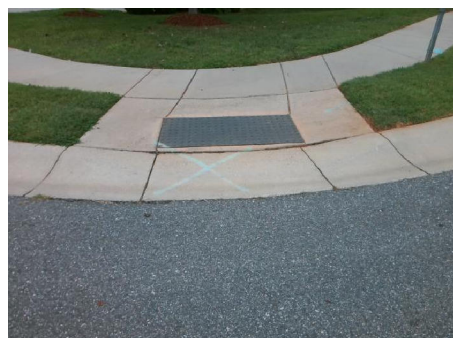
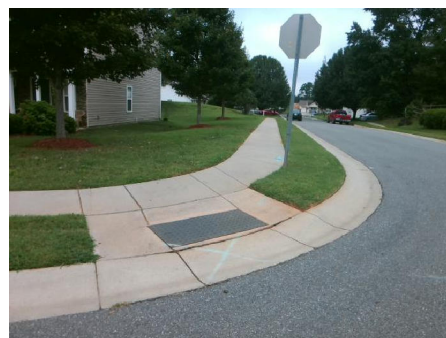
| ADA ID: 43A66B7E41BD | Ramp Type: BlendTrans1 | Initial Pass/Fail: Fail | Overall Compliance: No |

| Severity Score: 10 | | | |

**Not Found, R304.5.1, R304.5.3**

| Compliance | Description | Data | Compliance | Description | Data |
|---|---|---|---|---|---|
| No | Ramp Width (in) | 46.0 | No | BlendTrans XSlope (%) | 3.4 |
| | | | No | Curb Slope (%) | 13.2 |

**Remove & Replace Curb Ramp With Two New Directional Ramps or Equivalent.**

Total Cost: \$ 3200.00
