# Access Compliance Report

## Public Rights-of-Way

### (Curb Ramps)

Intersection ID: 19730	Main Street: SOUTH_PARK_DR	Cross Street: MORRISON BV	Location: SE
ADA ID: 43BBABB29556	Ramp Type: Perp	Initial Pass/Fail: Fail	Overall Compliance: No
			Severity Score: 33.75

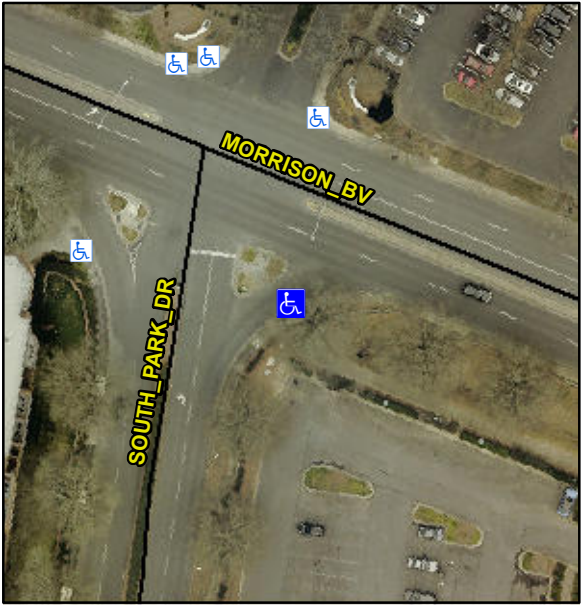
Possible Solutions:		<b>Compliance</b>	<b>Description</b>	<b>Data</b>
	<b>Remove &amp; Replace Entire Ramp.</b>		<b>No</b>	Ramp Length (in)	155.0
			<b>No</b>	Ramp Width (in)	46.5
			<b>N/A</b>	Flare Type LT	N/A
			<b>N/A</b>	Flare Slope LT (%)	N/A
			<b>N/A</b>	Flare Traversable LT?	N/A
			<b>N/A</b>	Landing Length (in)	N/A
			<b>N/A</b>	Landing Width (in)	N/A
			<b>N/A</b>	Landing Slope (%)	N/A
			<b>N/A</b>	Landing X Slope (%)	N/A
<p>Surveyor Notes:</p> <p><b>N/A</b></p> <p>PROW/ADA:</p> <p><b>Not Found, R304.5.1, R304.2.2</b></p>			<b>N/A</b>	Flare Type RT	N/A
			<b>N/A</b>	Flare Slope RT (%)	N/A
			<b>N/A</b>	Flare Traversable RT?	N/A
			<b>N/A</b>	DWS Provided?	N/A
			<b>N/A</b>	DWS Contrast?	N/A
			<b>N/A</b>	DWS Length (in)	N/A
			<b>N/A</b>	DWS Full Width?	N/A
			<b>N/A</b>	DWS Offset (in)	N/A
			<b>N/A</b>	Shared Landing?	N/A
