# Access Compliance Report

## Public Rights-of-Way

### (Curb Ramps)

Intersection ID: 27197	Main Street: BALLANTYNE COMMONS PY	Cross Street: CRESTWOOD DR	Location: SE
ADA ID: 43C829C679C4	Ramp Type: Perp	Initial Pass/Fail: Fail	Overall Compliance: No
Severity Score: 10			
Codes/Mitigation Info/Possible Solution		Field Measurements/Component Compliance

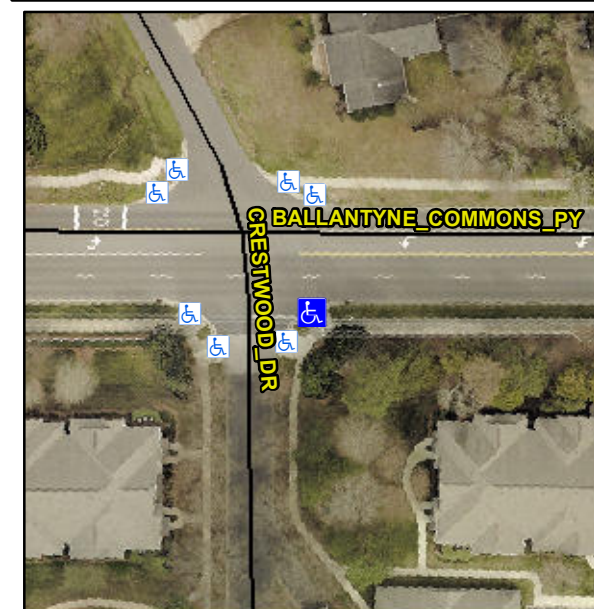
Compliance	Description	Data	Compliance	Description	Data
N/A	Ramp Length (in)	95.0	Yes	Ramp Slope (%)	7.7
No	Ramp Width (in)	38.0	No	Ramp XSlope (%)	4.4
N/A	Flare Type LT	N/A	N/A	Flare Type RT	N/A
N/A	Flare Slope LT (%)	N/A	N/A	Flare Slope RT (%)	N/A
N/A	Flare Traversable LT?	N/A	N/A	Flare Traversable RT?	N/A
N/A	Landing Length (in)	N/A	N/A	DWS Provided?	N/A
N/A	Landing Width (in)	N/A	N/A	DWS Contrast?	N/A
N/A	Landing Slope (%)	N/A	N/A	DWS Length (in)	N/A
N/A	Landing X Slope (%)	N/A	N/A	DWS Full Width?	N/A
N/A	Landing Curb? (Y/N)	N/A	N/A	DWS Offset (in)	N/A
N/A	Shared Landing?	N/A			
N/A	Gutter Ponding?	N/A	N/A	Gutter Slope (%)	N/A
N/A	Gutter Lip Ht (in)	N/A	N/A	Gutter X Slope (%)	N/A
N/A	Painted X Walk1?	No	N/A	Painted X Walk2?	N/A
	X Walk 1 Direction	To NE		X Walk 2 Direction	N/A
N/A	X Walk 1 Width (in)	N/A	N/A	X Walk 2 Width (in)	N/A
	X Walk 1 Slope (%)	3.4		X Walk 2 Slope (%)	N/A
	X Walk 1 X Slope (%)	2.0		X Walk 2 X Slope (%)	N/A

N/A	Ramp inside XWalk1?	N/A	N/A	Ramp inside XWalk2?	N/A
	Road Slope (%)	N/A	N/A	Clear Space?	N/A
	Road X Slope (%)	N/A	N/A	Clear Space to XWalk (in)	N/A
N/A	Any Obstructions?	N/A	N/A	Storm Grate/Utility Hazard?	N/A
	Obstruction Type			Storm Grate/Utility Type	
		N/A			N/A
			Yes	Surface Condition? (G/P)	Good

Possible Solutions:

**Remove & Replace Entire Ramp.**

**R304.5.1, R304.5.3**

Total Cost: \$ 1850.00
