## **Access Compliance Report Public Rights-of-Way** (Curb Ramps)

Intersection ID: 10034513 Main Street: PINEVILLE-MATTHEWS RD Cross Street: N/A Location: NW Initial Pass/Fail: Fail **Overall Compliance: No** ADA ID: 43DD9E08880C Ramp Type: PerpDiag Severity Score: 21.25

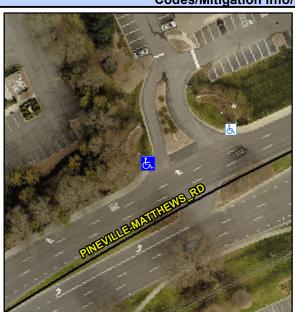
PINEVILLE-MATTHEWS RD Street 1 Name Stop Condition-Street 2 **ENTRANCE** Street 2 Name Stop Condition-Street 1 StopSign Possible Solutions: Remove & Replace Curb Ramp With Two New Directional Ramps or Equivalent. Surveyor Notes: N/A PROW/ADA: Not Found, R304.5.1, R304.2.2

No Ramp Slope (%) N/A Ramp Length (in) 58.5 8.7 Yes Ramp XSlope (%) No Ramp Width (in) 42.0 0.6 N/A N/A Flare Type LT N/A Flare Type RT N/A N/A Flare Slope LT (%) N/A N/A Flare Slope RT (%) N/A N/A Flare Traversable LT? N/A N/A Flare Traversable RT? N/A N/A Landing Length (in) N/A N/A DWS Provided? N/A N/A Landing Width (in) N/A N/A **DWS Contrast?** N/A N/A N/A N/A Landing Slope (%) DWS Length (in) N/A N/A Landing X Slope (%) N/A N/A DWS Full Width? N/A N/A Landing Curb? (Y/N) N/A N/A DWS Offset (in) N/A N/A N/A Shared Landing? N/A **Gutter Ponding?** N/A N/A Gutter Slope (%) N/A N/A Gutter Lip Ht (in) N/A N/A Gutter X Slope (%) N/A N/A Painted X Walk1? No N/A Painted X Walk2? No X Walk 1 Direction To SE X Walk 2 Direction To NE N/A N/A N/A X Walk 1 Width (in) X Walk 2 Width (in) X Walk 1 Slope (%) 4.3 X Walk 2 Slope (%) 1.3 X Walk 1 X Slope (%) 0.1 X Walk 2 X Slope (%) 3.1 N/A N/A N/A Ramp inside XWalk2? N/A Ramp inside XWalk1? Road Slope (%) 2.7 N/A Clear Space? N/A N/A Road X Slope (%) 3.5 Clear Space to XWalk (in) N/A N/A N/A N/A Any Obstructions? Storm Grate/Utility Hazard? N/A **Obstruction Type** Storm Grate/Utility Type N/A N/A Yes Surface Condition? (G/P) Good

Total Cost: 3200.00
