# Access Compliance Report

## Public Rights-of-Way

### (Curb Ramps)

Intersection ID: 53229	Main Street: BERRYHILL_RD	Cross Street: MAJOR_SAMUALS_WY	Location: SE
ADA ID: 43EB0A1BE247	Ramp Type: Perp	Initial Pass/Fail: Fail	Overall Compliance: No
			Severity Score: 13.75

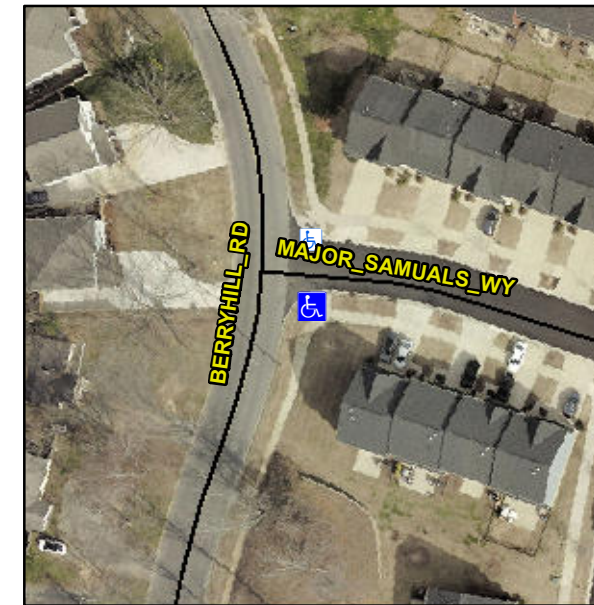
**Not Found, R304.2.2, R304.5.3**

Compliance	Description	Data	Compliance	Description	Data
N/A	Ramp Length (in)	116.0	No	Ramp Slope (%)	11.3
Yes	Ramp Width (in)	48.0	No	Ramp XSlope (%)	2.5
N/A	Flare Type LT	N/A	N/A	Flare Type RT	N/A
N/A	Flare Slope LT (%)	N/A	N/A	Flare Slope RT (%)	N/A
N/A	Flare Traversable LT?	N/A	N/A	Flare Traversable RT?	N/A
N/A	Landing Length (in)	N/A	N/A	DWS Provided?	N/A
N/A	Landing Width (in)	N/A	N/A	DWS Contrast?	N/A
N/A	Landing Slope (%)	N/A	N/A	DWS Length (in)	N/A
N/A	Landing X Slope (%)	N/A	N/A	DWS Full Width?	N/A
N/A	Landing Curb? (Y/N)	N/A	N/A	DWS Offset (in)	N/A
N/A	Shared Landing?	N/A			
N/A	Gutter Ponding?	N/A	N/A	Gutter Slope (%)	N/A
N/A	Gutter Lip Ht (in)	N/A	N/A	Gutter X Slope (%)	N/A
N/A	Painted X Walk1?	No	N/A	Painted X Walk2?	N/A
	X Walk 1 Direction	To N		X Walk 2 Direction	N/A
N/A	X Walk 1 Width (in)	N/A	N/A	X Walk 2 Width (in)	N/A
	X Walk 1 Slope (%)	0.3		X Walk 2 Slope (%)	N/A
	X Walk 1 X Slope (%)	5.0		X Walk 2 X Slope (%)	N/A

N/A	Ramp inside XWalk1?	N/A	N/A	Ramp inside XWalk2?	N/A
	Road Slope (%)	N/A	N/A	Clear Space?	N/A
	Road X Slope (%)	N/A	N/A	Clear Space to XWalk (in)	N/A
N/A	Any Obstructions?	N/A	N/A	Storm Grate/Utility Hazard?	N/A
	Obstruction Type			Storm Grate/Utility Type	
		N/A			N/A
			Yes	Surface Condition? (G/P)	Good

**Remove & Replace Entire Ramp.**
