## Access Compliance Report Public Rights-of-Way (Curb Ramps)

Intersection ID: 23936 Main Street: CANDLEWYCK\_LN Cross Street: LAWTON BLUFF RD Location: SE

ADA ID: 43EC9A9C0BDA Ramp Type: PerpDiag Initial Pass/Fail: Fail Overall Compliance: No Severity Score: 21.25

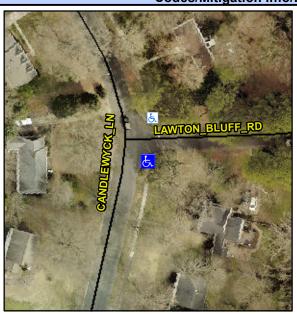
Not Found, R304.5.1, R304.2.2

Compliance Description <u>Data</u> Compliance Description Data No N/A Ramp Length (in) 65.0 Ramp Slope (%) 10.0 Yes Ramp XSlope (%) No Ramp Width (in) 46.5 8.0 N/A N/A Flare Type LT N/A Flare Type RT N/A N/A N/A N/A Flare Slope RT (%) N/A Flare Slope LT (%) N/A Flare Traversable LT? N/A N/A Flare Traversable RT? N/A N/A N/A N/A **DWS Provided?** N/A Landing Length (in) N/A Landing Width (in) N/A N/A **DWS Contrast?** N/A N/A N/A N/A Landing Slope (%) DWS Length (in) N/A N/A Landing X Slope (%) N/A N/A DWS Full Width? N/A N/A Landing Curb? (Y/N) N/A N/A DWS Offset (in) N/A N/A N/A Shared Landing? N/A Gutter Ponding? N/A N/A Gutter Slope (%) N/A N/A Gutter Lip Ht (in) N/A N/A Gutter X Slope (%) N/A N/A Painted X Walk1? No N/A Painted X Walk2? No X Walk 1 Direction To N X Walk 2 Direction To W N/A N/A X Walk 1 Width (in) X Walk 2 Width (in) N/A X Walk 1 Slope (%) X Walk 2 Slope (%) 7.1 3.1 X Walk 2 X Slope (%) X Walk 1 X Slope (%) 3.8 8.0 N/A N/A N/A Ramp inside XWalk2? N/A Ramp inside XWalk1? Road Slope (%) 7.7 N/A Clear Space? N/A N/A Road X Slope (%) 6.4 Clear Space to XWalk (in) N/A N/A N/A Any Obstructions? N/A Storm Grate/Utility Hazard? N/A **Obstruction Type** Storm Grate/Utility Type N/A N/A

Remove & Replace Curb Ramp With Two New Directional Ramps or Equivalent.
