# Access Compliance Report

## Public Rights-of-Way

### (Curb Ramps)

| Intersection ID: 14659 | Main Street: E_WORTHINGTON_AV | Cross Street: SPRINGDALE_AV | Location: N |

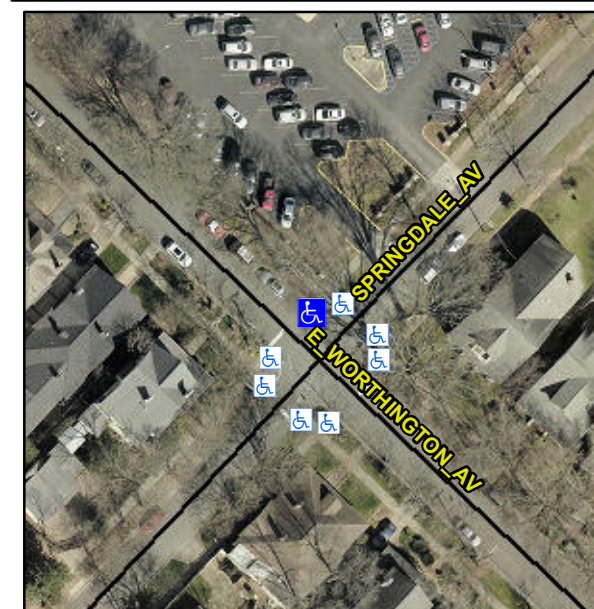
| ADA ID: 43FA3AF23CFF | Ramp Type: Directional1 | Initial Pass/Fail: Fail | Overall Compliance: No |

**R304.5.1, R304.2.2, R304.5.3**

| Compliance | Description | Data | Compliance | Description | Data |
|---|---|---|---|---|---|
| No | Ramp Width (in) | 36.0 | N/A | Grade Break Slope (%) | 0.0 |
| No | Ramp Slope (%) | 12.8 | N/A | Grade Break XSlope (%) | 0.0 |
| No | Ramp XSlope (%) | 5.1 | | | |

**Remove & Replace Entire Ramp.**

Total Cost: \$ 1600.00
