Access Compliance Report

Public Rights-of-Way

(Curb Ramps)

Intersection ID: 18104	Main Street: ROBIN_RD	Cross Street: S_SHARON_AMITY_RD	Location: SE
ADA ID: 4400A0830A67	Ramp Type: PerpDiag	Initial Pass/Fail: Fail	Overall Compliance: No
		Severity Score: 35

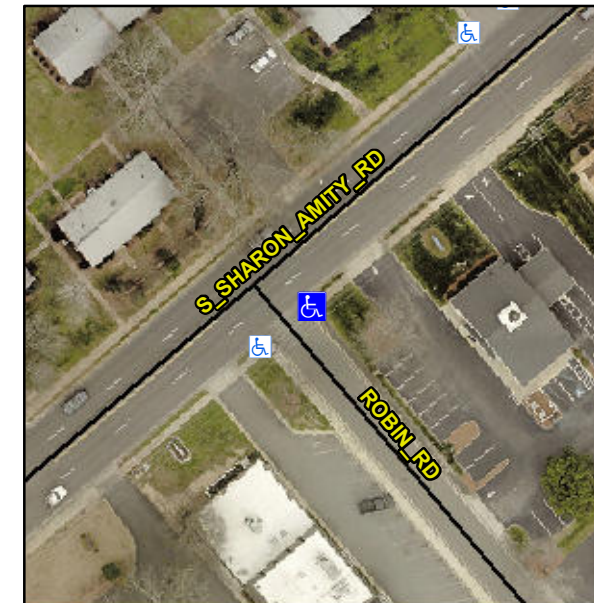
Not Found, R304.5.1, R304.2.2, R304.5.3

Compliance	Description	Data	Compliance	Description	Data
N/A	Ramp Length (in)	54.0	No	Ramp Slope (%)	12.8
No	Ramp Width (in)	39.0	No	Ramp XSlope (%)	2.4
N/A	Flare Type LT	N/A	N/A	Flare Type RT	N/A
N/A	Flare Slope LT (%)	N/A	N/A	Flare Slope RT (%)	N/A
N/A	Flare Traversable LT?	N/A	N/A	Flare Traversable RT?	N/A
N/A	Landing Length (in)	N/A	N/A	DWS Provided?	N/A
N/A	Landing Width (in)	N/A	N/A	DWS Contrast?	N/A
N/A	Landing Slope (%)	N/A	N/A	DWS Length (in)	N/A
N/A	Landing X Slope (%)	N/A	N/A	DWS Full Width?	N/A
N/A	Landing Curb? (Y/N)	N/A	N/A	DWS Offset (in)	N/A
N/A	Shared Landing?	N/A			
N/A	Gutter Ponding?	N/A	N/A	Gutter Slope (%)	N/A
N/A	Gutter Lip Ht (in)	N/A	N/A	Gutter X Slope (%)	N/A
N/A	Painted X Walk1?	No	N/A	Painted X Walk2?	No
	X Walk 1 Direction	To NW		X Walk 2 Direction	To SW
N/A	X Walk 1 Width (in)	N/A	N/A	X Walk 2 Width (in)	N/A
	X Walk 1 Slope (%)	3.5		X Walk 2 Slope (%)	2.1
	X Walk 1 X Slope (%)	2.8		X Walk 2 X Slope (%)	0.7

N/A	Ramp inside XWalk1?	N/A	N/A	Ramp inside XWalk2?	N/A
	Road Slope (%)	1.7	N/A	Clear Space?	N/A
	Road X Slope (%)	4.4	N/A	Clear Space to XWalk (in)	N/A
N/A	Any Obstructions?	N/A	N/A	Storm Grate/Utility Hazard?	N/A
	Obstruction Type			Storm Grate/Utility Type	
		N/A			N/A
			Yes	Surface Condition? (G/P)	Good

Remove & Replace Curb Ramp With Two New Directional Ramps or Equivalent.
