# Access Compliance Report

## Public Rights-of-Way

| Intersection ID: 15956 | Main Street: POINDEXTER_DR | Cross Street: SEDGEFIELD_RD | Location: W |
| ADA ID: 4405B98C2AA7 | Ramp Type: PerpDiag | Initial Pass/Fail: Fail | Overall Compliance: No |

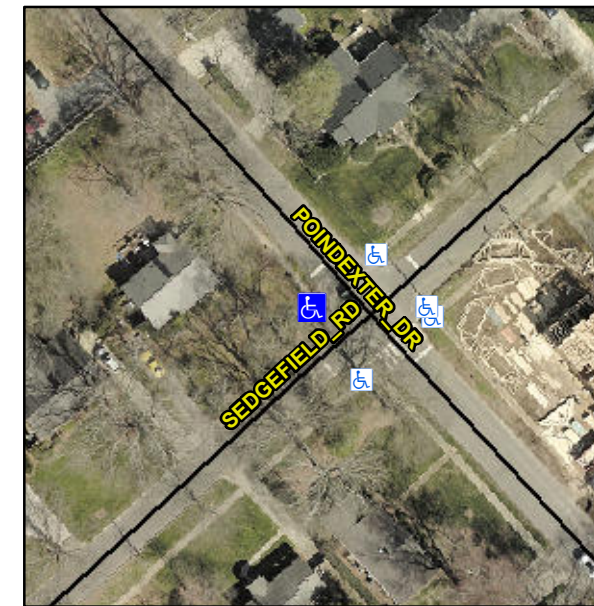
| | | Severity Score: 22.5 | |

**Not Found, R304.5.1, R304.2.2, R304.5.3**

| Compliance | Description | Data | Compliance | Description | Data |
|---|---|---|---|---|---|
| N/A | Ramp Length (in) | 62.0 | No | Ramp Slope (%) | 10.5 |
| No | Ramp Width (in) | 47.0 | No | Ramp XSlope (%) | 4.5 |

**Remove & Replace Curb Ramp With Two New Directional Ramps or Equivalent.**

Total Cost: \$ 3200.00
