Access Compliance Report

Public Rights-of-Way

(Curb Ramps)

| Intersection ID: 17870 | Main Street: HILLSDALE_AV | Cross Street: TRANQUIL_AV | Location: SW |

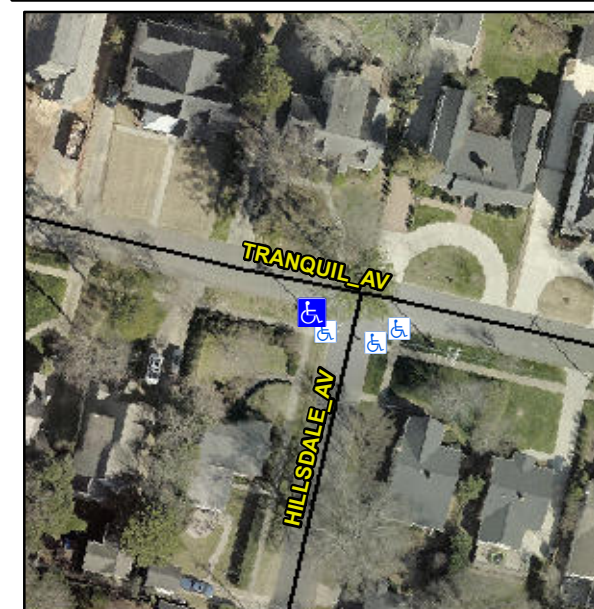
| ADA ID: 44081121FECF | Ramp Type: Perp | Initial Pass/Fail: Fail | Overall Compliance: No |
| Severity Score: 46.25 | | | |

Not Found, R304.5.1, R304.2.2, R304.5.3

| Compliance | Description | Data | Compliance | Description | Data |
|---|---|---|---|---|---|
| N/A | Ramp Length (in) | 102.0 | No | Ramp Slope (%) | 10.2 |
| No | Ramp Width (in) | 39.0 | No | Ramp XSlope (%) | 15.3 |

Remove & Replace Entire Ramp.
