# Access Compliance Report

## Public Rights-of-Way

### (Curb Ramps)

Intersection ID: 10033177	Main Street: NORWICH_PL	Cross Street: WICKHAM_LN	Location: SE
ADA ID: 44181780A9E1	Ramp Type: PerpDiag	Initial Pass/Fail: Fail	Overall Compliance: No
		Severity Score: 10

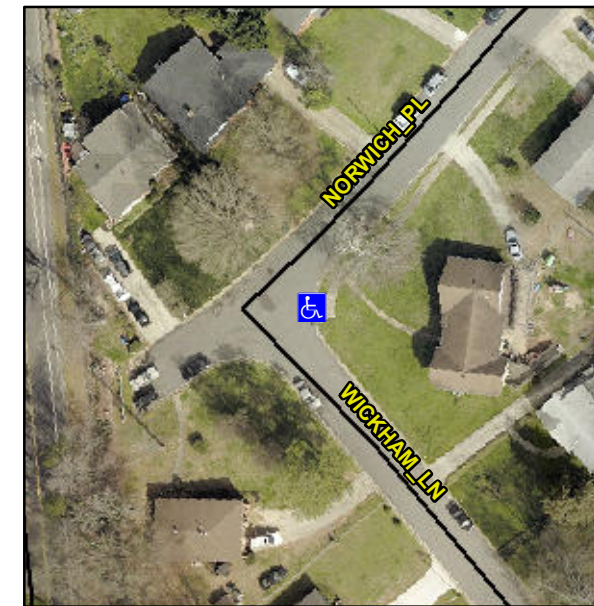
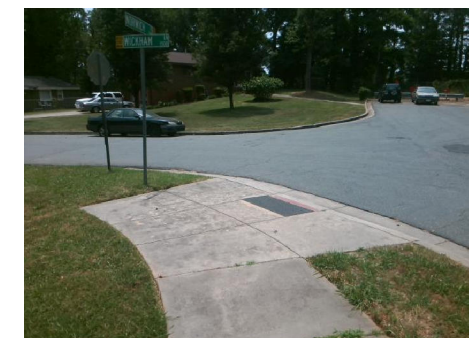
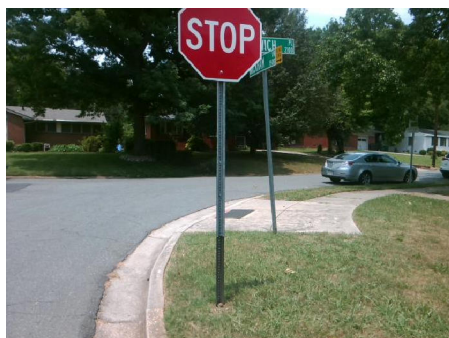
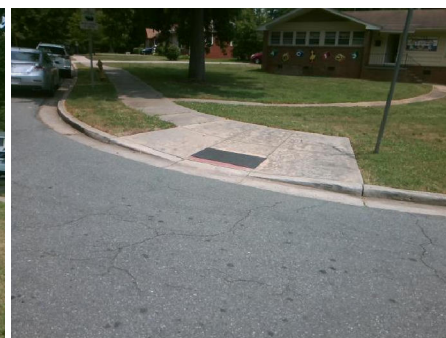
**Not Found, R304.5.1, R304.5.3**

Compliance	Description	Data	Compliance	Description	Data
N/A	Ramp Length (in)	120.0	Yes	Ramp Slope (%)	5.4
No	Ramp Width (in)	36.0	No	Ramp XSlope (%)	2.8
N/A	Flare Type LT	N/A	N/A	Flare Type RT	N/A
N/A	Flare Slope LT (%)	N/A	N/A	Flare Slope RT (%)	N/A
N/A	Flare Traversable LT?	N/A	N/A	Flare Traversable RT?	N/A
N/A	Landing Length (in)	N/A	N/A	DWS Provided?	N/A
N/A	Landing Width (in)	N/A	N/A	DWS Contrast?	N/A
N/A	Landing Slope (%)	N/A	N/A	DWS Length (in)	N/A
N/A	Landing X Slope (%)	N/A	N/A	DWS Full Width?	N/A
N/A	Landing Curb? (Y/N)	N/A	N/A	DWS Offset (in)	N/A
N/A	Shared Landing?	N/A			
N/A	Gutter Ponding?	N/A	N/A	Gutter Slope (%)	N/A
N/A	Gutter Lip Ht (in)	N/A	N/A	Gutter X Slope (%)	N/A
N/A	Painted X Walk1?	No	N/A	Painted X Walk2?	No
	X Walk 1 Direction	To N		X Walk 2 Direction	To W
N/A	X Walk 1 Width (in)	N/A	N/A	X Walk 2 Width (in)	N/A
	X Walk 1 Slope (%)	7.7		X Walk 2 Slope (%)	0.2
	X Walk 1 X Slope (%)	2.0		X Walk 2 X Slope (%)	4.6

N/A	Ramp inside XWalk1?	N/A	N/A	Ramp inside XWalk2?	N/A
	Road Slope (%)	3.0	N/A	Clear Space?	N/A
	Road X Slope (%)	8.4	N/A	Clear Space to XWalk (in)	N/A
N/A	Any Obstructions?	N/A	N/A	Storm Grate/Utility Hazard?	N/A
	Obstruction Type			Storm Grate/Utility Type	
		N/A			N/A
			Yes	Surface Condition? (G/P)	Good

**Remove & Replace Curb Ramp With Two New Directional Ramps or Equivalent.**

Total Cost: \$ 3200.00
