Access Compliance Report

Public Rights-of-Way

(Curb Ramps)

Intersection ID: 6087	Main Street: RUMSTONE_LN	Cross Street: WINGSTONE_LN	Location: S
ADA ID: 441EA72738AF	Ramp Type: Perp	Initial Pass/Fail: Fail	Overall Compliance: No
		Severity Score: 12.5

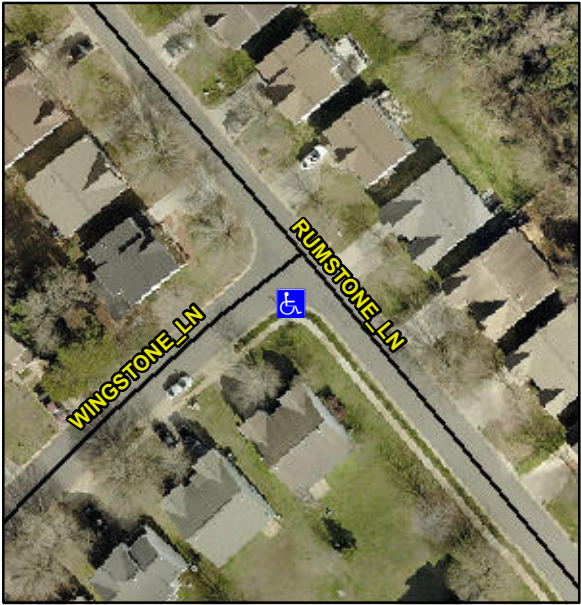
Possible Solutions:		Compliance	Description	Data
	Remove & Replace Entire Ramp.		Yes	Ramp Length (in)	48.0
			N/A	Ramp Width (in)	48.0
			N/A	Flare Type LT	N/A
			N/A	Flare Slope LT (%)	N/A
			N/A	Flare Traversable LT?	N/A
			N/A	Landing Length (in)	N/A
			N/A	Landing Width (in)	N/A
			N/A	Landing Slope (%)	N/A
			N/A	Landing X Slope (%)	N/A
<p>Surveyor Notes:</p> <p>N/A</p> <p>PROW/ADA:</p> <p>Not Found, R304.5.3</p>			N/A	Flare Type RT	N/A
			N/A	Flare Slope RT (%)	N/A
			N/A	Flare Traversable RT?	N/A
			N/A	DWS Provided?	N/A
			N/A	DWS Contrast?	N/A
			N/A	DWS Length (in)	N/A
			N/A	DWS Full Width?	N/A
			N/A	DWS Offset (in)	N/A
			N/A	Shared Landing?	N/A
			N/A	Gutter Ponding?	N/A
			N/A	Gutter Lip Ht (in)	N/A
			N/A	Painted X Walk1?	No
			To N	X Walk 1 Direction	N/A
			N/A	X Walk 1 Width (in)	N/A

1.0	X Walk 1 Slope (%)	N/A
			5.0	X Walk 1 X Slope (%)	N/A
			N/A	Ramp inside XWalk1?	N/A
			N/A	Road Slope (%)	N/A
			N/A	Road X Slope (%)	N/A
			N/A	Any Obstructions?	N/A
			N/A	Obstruction Type	N/A
			N/A	Clear Space?	N/A
			N/A	Clear Space to XWalk (in)	N/A
			N/A	Storm Grate/Utility Hazard?	N/A
			N/A	Storm Grate/Utility Type	N/A
			N/A	Surface Condition? (G/P)	Good
Total Cost:		\$ 1850.00
