Access Compliance Report

Public Rights-of-Way

(Curb Ramps)

Intersection ID: 14556	Main Street: E_WORTHINGTON_AV	Cross Street: WINTHROP_AV	Location:	N
ADA ID: 4426418CE1E8	Ramp Type: Perp	Initial Pass/Fail: Fail	Overall Compliance: No	Severity Score: 22.5
Codes/Mitigation Info/Possible Solution		Field Measurements/Component Compliance

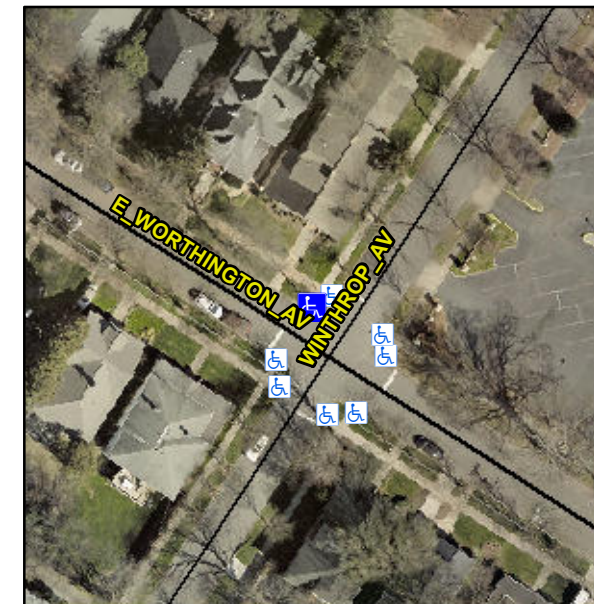
Not Found, R304.5.1, R304.2.2, R304.5.3

Compliance	Description	Data	Compliance	Description	Data
N/A	Ramp Length (in)	98.0	No	Ramp Slope (%)	9.3
No	Ramp Width (in)	42.0	No	Ramp XSlope (%)	4.1
N/A	Flare Type LT	N/A	N/A	Flare Type RT	N/A
N/A	Flare Slope LT (%)	N/A	N/A	Flare Slope RT (%)	N/A
N/A	Flare Traversable LT?	N/A	N/A	Flare Traversable RT?	N/A
N/A	Landing Length (in)	N/A	N/A	DWS Provided?	N/A
N/A	Landing Width (in)	N/A	N/A	DWS Contrast?	N/A
N/A	Landing Slope (%)	N/A	N/A	DWS Length (in)	N/A
N/A	Landing X Slope (%)	N/A	N/A	DWS Full Width?	N/A
N/A	Landing Curb? (Y/N)	N/A	N/A	DWS Offset (in)	N/A
N/A	Shared Landing?	N/A			
N/A	Gutter Ponding?	N/A	N/A	Gutter Slope (%)	N/A
N/A	Gutter Lip Ht (in)	N/A	N/A	Gutter X Slope (%)	N/A
N/A	Painted X Walk1?	No	N/A	Painted X Walk2?	N/A
	X Walk 1 Direction	To SW		X Walk 2 Direction	N/A
N/A	X Walk 1 Width (in)	N/A	N/A	X Walk 2 Width (in)	N/A
	X Walk 1 Slope (%)	3.9		X Walk 2 Slope (%)	N/A
	X Walk 1 X Slope (%)	0.4		X Walk 2 X Slope (%)	N/A

N/A	Ramp inside XWalk1?	N/A	N/A	Ramp inside XWalk2?	N/A
	Road Slope (%)	N/A	N/A	Clear Space?	N/A
	Road X Slope (%)	N/A	N/A	Clear Space to XWalk (in)	N/A
N/A	Any Obstructions?	N/A	N/A	Storm Grate/Utility Hazard?	N/A
	Obstruction Type			Storm Grate/Utility Type	
		N/A			N/A
			Yes	Surface Condition? (G/P)	Good

Possible Solutions:

Remove & Replace Entire Ramp.
