## **Access Compliance Report Public Rights-of-Way** (Curb Ramps)

Intersection ID: 47849 Main Street: SERAPE RD **Cross Street: STONE PORCH RD** Location: SW ADA ID: 442EFA770E7B Ramp Type: BlendTrans2 Initial Pass/Fail: Fail **Overall Compliance: No Severity Score:** 8.75

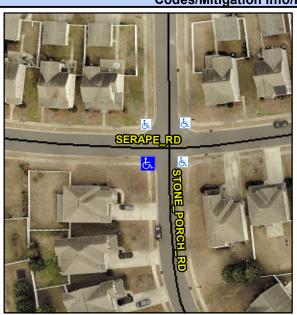
Not Found, R304.5.1

Field Measurements/Component Compliance					
Compliance Description		Data	Compliance Description		Data
N/A	Ramp Length (in)	96.0	Yes	BlendTrans Slope (%)	4.6
No	Ramp Width (in)	46.5	Yes	BlendTrans XSlope (%)	1.5
N/A	Flare Type LT	N/A	N/A	Flare Type RT	N/A
N/A	Flare Slope LT (%)	N/A	N/A	Flare Slope RT (%)	N/A
N/A	Flare Traversable LT?	N/A	N/A	Flare Traversable RT?	N/A
N/A	Landing Length (in)	N/A	N/A	DWS Provided?	N/A
N/A	Landing Width (in)	N/A	N/A	DWS Contrast?	N/A
N/A	Landing Slope (%)	N/A	N/A	DWS Length (in)	N/A
N/A	Landing X Slope (%)	N/A	N/A	DWS Full Width?	N/A
N/A	Landing Curb? (Y/N)	N/A	N/A	DWS Offset (in)	N/A
N/A	Shared Landing?	N/A			
N/A	Gutter Ponding?	N/A	N/A	Gutter Slope (%)	N/A
N/A	Gutter Lip Ht (in)	N/A	N/A	Gutter X Slope (%)	N/A
N/A	Painted X Walk1?	No	N/A	Painted X Walk2?	No
	X Walk 1 Direction	To E		X Walk 2 Direction	To N
	X Walk 1 Width (in)	N/A		X Walk 2 Width (in)	N/A
	X Walk 1 Slope (%)	0.0		X Walk 2 Slope (%)	1.0

X Walk 1 X Slope (%)	2.4		X Walk 2 X Slope (%)	0.2
N/A	Ramp inside XWalk1?	N/A	N/A	Ramp inside XWalk2?	N/A
	Road Slope (%)	1.6		Clear Space?	N/A
	Road X Slope (%)	2.7	N/A	Clear Space to XWalk (in)	N/A
N/A	Any Obstructions?	N/A	N/A	Storm Grate/Utility Hazard?	N/A
	Obstruction Type			Storm Grate/Utility Type	
		N/A			N/A
			Yes	Surface Condition? (G/P)	Good
	30		No	Curb Slope (%)	6.0

Possible Solutions: Remove & Replace Curb Ramp With Two New Directional Ramps or Equivalent.
