Access Compliance Report

Public Rights-of-Way

(Curb Ramps)

Intersection ID: 10035708	Main Street: REDDMAN_RD	Cross Street: N/A	Location: SW
ADA ID: 44480EDD4DE6	Ramp Type: PerpDiag	Initial Pass/Fail: Fail	Overall Compliance: No
Severity Score: 31.25			
Codes/Mitigation Info/Possible Solution		Field Measurements/Component Compliance

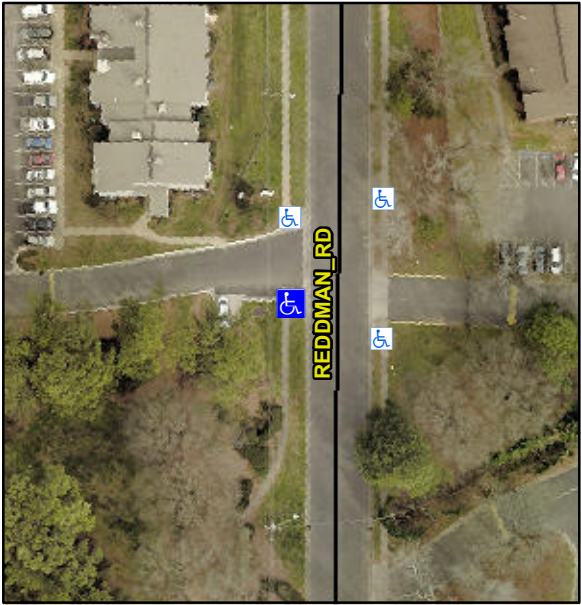
Possible Solutions:		Compliance		Description		Data	Compliance	Description	Data
	Remove & Replace Curb Ramp With Two New Directional Ramps or Equivalent.		N/A		Ramp Length (in)		55.0	No	Ramp Slope (%)	8.8
<p>Surveyor Notes:</p> <p>N/A</p> <p>PROW/ADA:</p> <p>Not Found, R304.5.1, R304.2.2, R304.5.3</p>			No		Ramp Width (in)		33.0	No	Ramp XSlope (%)	2.4
			N/A		Flare Type LT		N/A	N/A	Flare Type RT	N/A
<p>Street 1 Name</p> <p>REDDMAN RD</p> <p>Stop Condition-Street 2</p> <p>None</p> <p>Street 2 Name</p> <p>ENTRANCE</p> <p>Stop Condition-Street 1</p> <p>None</p>			N/A		Flare Slope LT (%)		N/A	N/A	Flare Slope RT (%)	N/A
			N/A		Flare Traversable LT?		N/A	N/A	Flare Traversable RT?	N/A
<p>Total Cost:</p> <p>\$ 3200.00</p>			N/A		Landing Length (in)		N/A	N/A	DWS Provided?	N/A
			N/A		Landing Width (in)		N/A	N/A	DWS Contrast?	N/A
			N/A		Landing Slope (%)		N/A	N/A	DWS Length (in)	N/A
			N/A		Landing X Slope (%)		N/A	N/A	DWS Full Width?	N/A

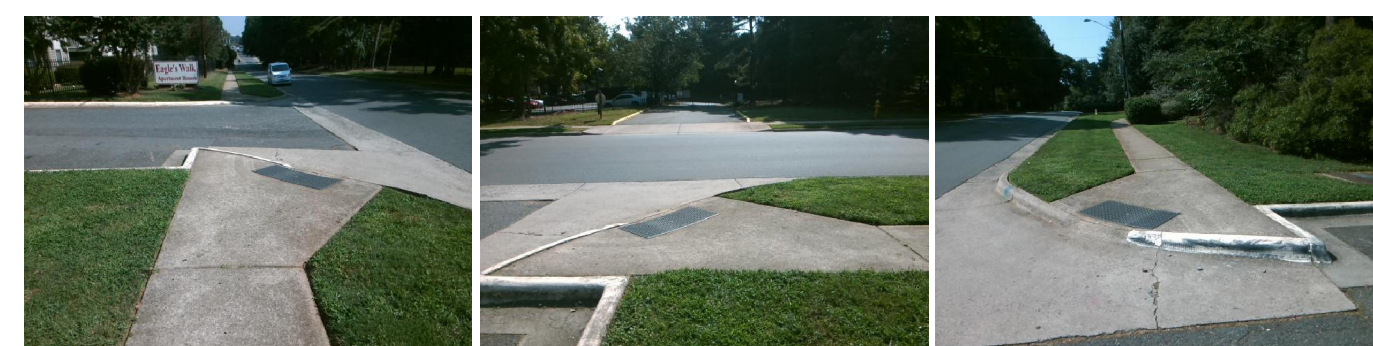
N/A		Landing Curb? (Y/N)		N/A	N/A	DWS Offset (in)	N/A
			N/A		Shared Landing?		N/A			
			N/A		Gutter Ponding?		N/A	N/A	Gutter Slope (%)	N/A
			N/A		Gutter Lip Ht (in)		N/A	N/A	Gutter X Slope (%)	N/A
			N/A		Painted X Walk1?		No	N/A	Painted X Walk2?	No
					X Walk 1 Direction		To SE		X Walk 2 Direction	To N
			N/A		X Walk 1 Width (in)		N/A	N/A	X Walk 2 Width (in)	N/A
					X Walk 1 Slope (%)		6.0		X Walk 2 Slope (%)	4.2
					X Walk 1 X Slope (%)		3.9		X Walk 2 X Slope (%)	2.9
			N/A		Ramp inside XWalk1?		N/A	N/A	Ramp inside XWalk2?	N/A
					Road Slope (%)		0.1	N/A	Clear Space?	N/A
					Road X Slope (%)		5.9	N/A	Clear Space to XWalk (in)	N/A
			N/A		Any Obstructions?		N/A	N/A	Storm Grate/Utility Hazard?	N/A
					Obstruction Type				Storm Grate/Utility Type	
								N/A		N/A
								Yes	Surface Condition? (G/P)	Good
