# Access Compliance Report

## Public Rights-of-Way

### (Curb Ramps)

Intersection ID: 28976	Main Street: BANNINGTON_RD	Cross Street: CARMEL_COMMONS_BV	Location: NE
ADA ID: 444A66024838	Ramp Type: PerpDiag	Initial Pass/Fail: Fail	Overall Compliance: No
		Severity Score: 60

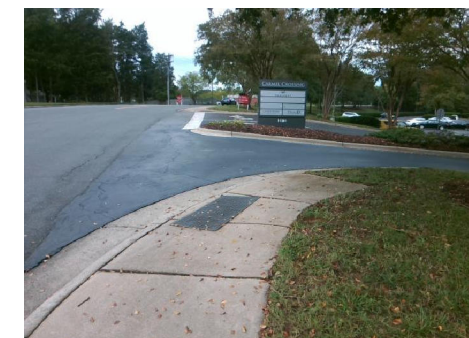
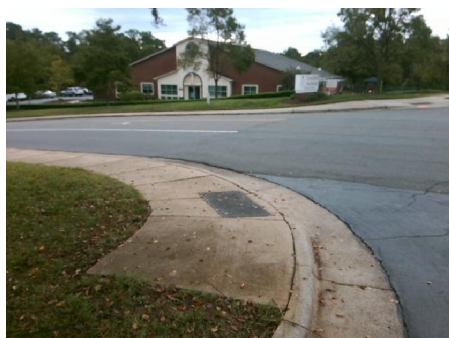
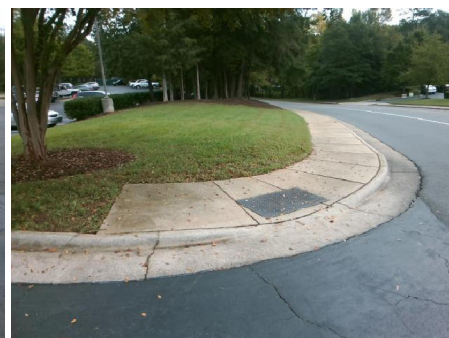
**Not Found, R304.5.1, R304.5.3**

Compliance	Description	Data	Compliance	Description	Data
N/A	Ramp Length (in)	60.0	Yes	Ramp Slope (%)	7.9
No	Ramp Width (in)	29.0	No	Ramp XSlope (%)	9.7
N/A	Flare Type LT	N/A	N/A	Flare Type RT	N/A
N/A	Flare Slope LT (%)	N/A	N/A	Flare Slope RT (%)	N/A
N/A	Flare Traversable LT?	N/A	N/A	Flare Traversable RT?	N/A
N/A	Landing Length (in)	N/A	N/A	DWS Provided?	N/A
N/A	Landing Width (in)	N/A	N/A	DWS Contrast?	N/A
N/A	Landing Slope (%)	N/A	N/A	DWS Length (in)	N/A
N/A	Landing X Slope (%)	N/A	N/A	DWS Full Width?	N/A
N/A	Landing Curb? (Y/N)	N/A	N/A	DWS Offset (in)	N/A
N/A	Shared Landing?	N/A			
N/A	Gutter Ponding?	N/A	N/A	Gutter Slope (%)	N/A
N/A	Gutter Lip Ht (in)	N/A	N/A	Gutter X Slope (%)	N/A
N/A	Painted X Walk1?	No	N/A	Painted X Walk2?	No
	X Walk 1 Direction	To W		X Walk 2 Direction	To S
N/A	X Walk 1 Width (in)	N/A	N/A	X Walk 2 Width (in)	N/A
	X Walk 1 Slope (%)	6.0		X Walk 2 Slope (%)	1.7
	X Walk 1 X Slope (%)	0.4		X Walk 2 X Slope (%)	7.4

N/A	Ramp inside XWalk1?	N/A	N/A	Ramp inside XWalk2?	N/A
	Road Slope (%)	4.3	N/A	Clear Space?	N/A
	Road X Slope (%)	5.9	N/A	Clear Space to XWalk (in)	N/A
N/A	Any Obstructions?	N/A	N/A	Storm Grate/Utility Hazard?	N/A
	Obstruction Type			Storm Grate/Utility Type	
		N/A			N/A
			Yes	Surface Condition? (G/P)	Good

**Remove & Replace Curb Ramp With Two New Directional Ramps or Equivalent.**
