# Access Compliance Report

## Public Rights-of-Way

| Intersection ID: 25757 | Main Street: BANNINGTON_RD | Cross Street: SHANNON_WILLOW_RD | Location: SW |
| ADA ID: 4454DD95134E | Ramp Type: PerpDiag | Initial Pass/Fail: Fail | Overall Compliance: No |

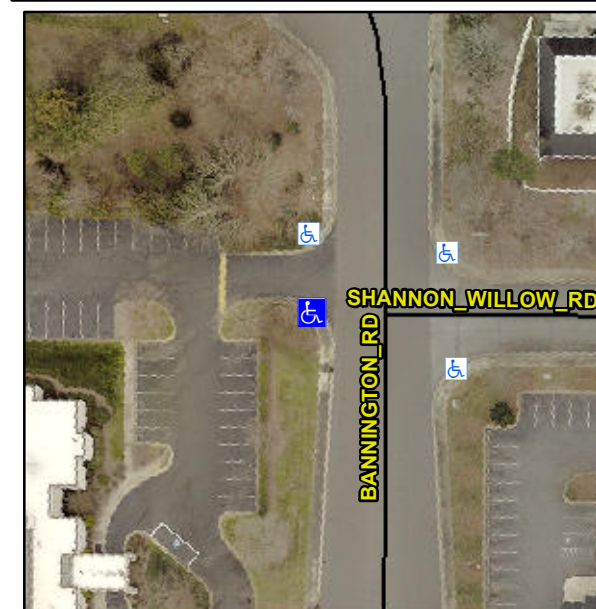
| Severity Score: 21.25 | | | |

**Not Found, R304.5.1, R304.2.2**

| Compliance | Description | Data | Compliance | Description | Data |
|---|---|---|---|---|---|
| N/A | Ramp Length (in) | 58.0 | No | Ramp Slope (%) | 9.0 |
| No | Ramp Width (in) | 40.0 | Yes | Ramp XSlope (%) | 1.6 |

**Remove & Replace Curb Ramp With Two New Directional Ramps or Equivalent.**

Total Cost: \$ 3200.00
