Access Compliance Report

Public Rights-of-Way

(Curb Ramps)

Intersection ID: 13115	Main Street: S_MINT_ST	Cross Street: WINONA_ST	Location: NW
ADA ID: 445BC6150AA5	Ramp Type: PerpDiag	Initial Pass/Fail: Fail	Overall Compliance: No
Severity Score: 26.25			
Codes/Mitigation Info/Possible Solution		Field Measurements/Component Compliance

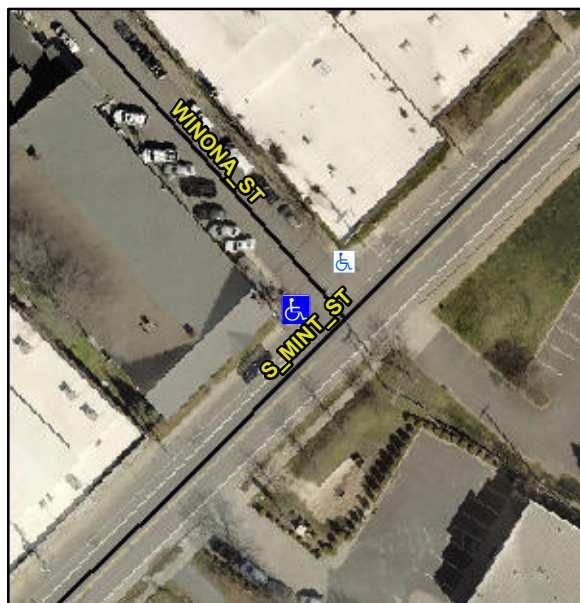
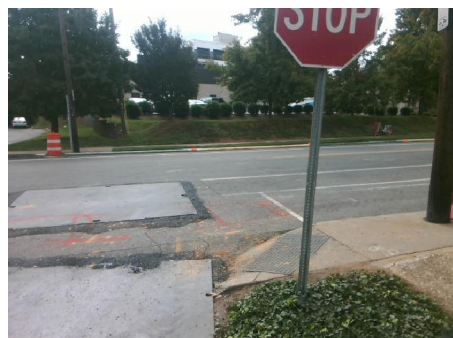
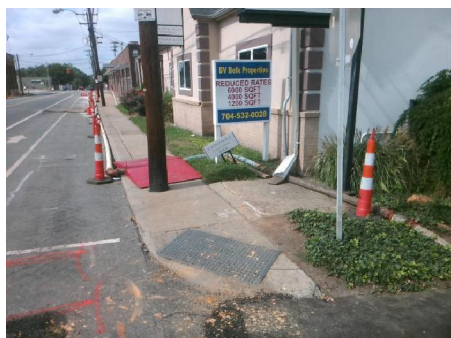
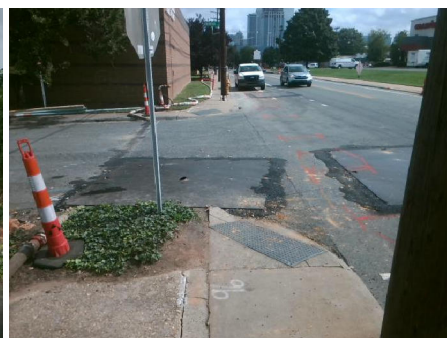
Not Found, R304.2.2, R304.5.3

Compliance	Description	Data	Compliance	Description	Data
N/A	Ramp Length (in)	24.0	No	Ramp Slope (%)	13.3
Yes	Ramp Width (in)	48.0	No	Ramp XSlope (%)	3.1
N/A	Flare Type LT	N/A	N/A	Flare Type RT	N/A
N/A	Flare Slope LT (%)	N/A	N/A	Flare Slope RT (%)	N/A
N/A	Flare Traversable LT?	N/A	N/A	Flare Traversable RT?	N/A
N/A	Landing Length (in)	N/A	N/A	DWS Provided?	N/A
N/A	Landing Width (in)	N/A	N/A	DWS Contrast?	N/A
N/A	Landing Slope (%)	N/A	N/A	DWS Length (in)	N/A
N/A	Landing X Slope (%)	N/A	N/A	DWS Full Width?	N/A
N/A	Landing Curb? (Y/N)	N/A	N/A	DWS Offset (in)	N/A
N/A	Shared Landing?	N/A			
N/A	Gutter Ponding?	N/A	N/A	Gutter Slope (%)	N/A
N/A	Gutter Lip Ht (in)	N/A	N/A	Gutter X Slope (%)	N/A
N/A	Painted X Walk1?	No	N/A	Painted X Walk2?	No
	X Walk 1 Direction	To SE		X Walk 2 Direction	To NE
N/A	X Walk 1 Width (in)	N/A	N/A	X Walk 2 Width (in)	N/A
	X Walk 1 Slope (%)	4.3		X Walk 2 Slope (%)	1.6
	X Walk 1 X Slope (%)	1.1		X Walk 2 X Slope (%)	4.5

N/A	Ramp inside XWalk1?	N/A	N/A	Ramp inside XWalk2?	N/A
	Road Slope (%)	2.2	N/A	Clear Space?	N/A
	Road X Slope (%)	4.2	N/A	Clear Space to XWalk (in)	N/A
N/A	Any Obstructions?	N/A	N/A	Storm Grate/Utility Hazard?	N/A
	Obstruction Type			Storm Grate/Utility Type	
		N/A			N/A
			Yes	Surface Condition? (G/P)	Good

Remove & Replace Curb Ramp With Two New Directional Ramps or Equivalent.
