Access Compliance Report

Public Rights-of-Way

(Curb Ramps)

Intersection ID: 48454	Main Street: RED_RUST_LN	Cross Street: GOLF_LINKS_DR	Location: NE
ADA ID: 445CC89E9B69	Ramp Type: Perp	Initial Pass/Fail: Fail	Overall Compliance: No Severity Score: 13.75

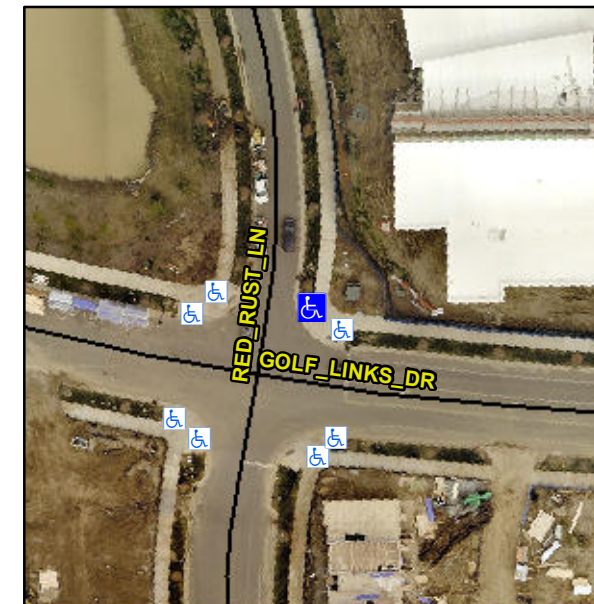
R304.2.2, R304.5.3

Compliance	Description	Data	Compliance	Description	Data
N/A	Ramp Length (in)	94.0	No	Ramp Slope (%)	9.1
Yes	Ramp Width (in)	61.0	No	Ramp XSlope (%)	5.0
N/A	Flare Type LT	N/A	N/A	Flare Type RT	N/A
N/A	Flare Slope LT (%)	N/A	N/A	Flare Slope RT (%)	N/A
N/A	Flare Traversable LT?	N/A	N/A	Flare Traversable RT?	N/A
N/A	Landing Length (in)	N/A	N/A	DWS Provided?	N/A
N/A	Landing Width (in)	N/A	N/A	DWS Contrast?	N/A
N/A	Landing Slope (%)	N/A	N/A	DWS Length (in)	N/A
N/A	Landing X Slope (%)	N/A	N/A	DWS Full Width?	N/A
N/A	Landing Curb? (Y/N)	N/A	N/A	DWS Offset (in)	N/A
N/A	Shared Landing?	N/A			
N/A	Gutter Ponding?	N/A	N/A	Gutter Slope (%)	N/A
N/A	Gutter Lip Ht (in)	N/A	N/A	Gutter X Slope (%)	N/A
N/A	Painted X Walk1?	No	N/A	Painted X Walk2?	N/A
	X Walk 1 Direction	To W		X Walk 2 Direction	N/A
N/A	X Walk 1 Width (in)	N/A	N/A	X Walk 2 Width (in)	N/A
	X Walk 1 Slope (%)	2.4		X Walk 2 Slope (%)	N/A
	X Walk 1 X Slope (%)	4.9		X Walk 2 X Slope (%)	N/A

N/A	Ramp inside XWalk1?	N/A	N/A	Ramp inside XWalk2?	N/A
	Road Slope (%)	N/A	N/A	Clear Space?	N/A
	Road X Slope (%)	N/A	N/A	Clear Space to XWalk (in)	N/A
N/A	Any Obstructions?	N/A	N/A	Storm Grate/Utility Hazard?	N/A
	Obstruction Type			Storm Grate/Utility Type	
		N/A			N/A
			Yes	Surface Condition? (G/P)	Good

Remove & Replace Entire Ramp.

Total Cost: \$ 1850.00
