# Access Compliance Report

## Public Rights-of-Way

### (Curb Ramps)

| Intersection ID: 53925 | Main Street: RORY_GLEN_LN | Cross Street: PINYON_PINE_LN | Location: NE |

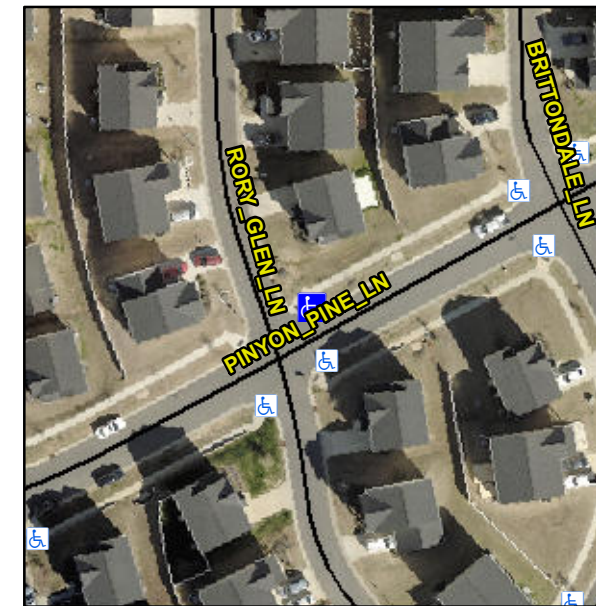
| ADA ID: 446C8557EF9D | Ramp Type: PerpDiag | Initial Pass/Fail: Fail | Overall Compliance: No |
| Severity Score: 46.25 | | | |

**Not Found, R304.5.1, R304.2.2, R304.5.3**

| Compliance | Description | Data | Compliance | Description | Data |
|---|---|---|---|---|---|
| N/A | Ramp Length (in) | 104.5 | No | Ramp Slope (%) | 9.3 |
| No | Ramp Width (in) | 42.0 | No | Ramp XSlope (%) | 7.4 |

**Remove & Replace Curb Ramp With Two New Directional Ramps or Equivalent.**

Total Cost: \$ 3200.00

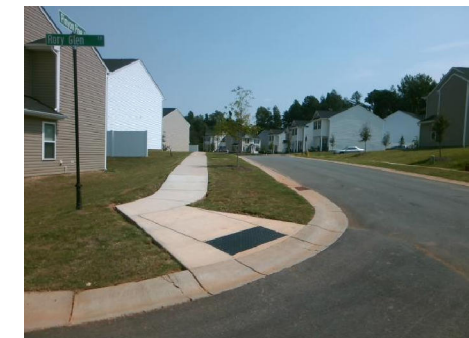
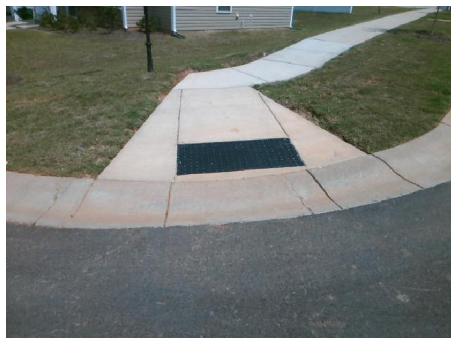
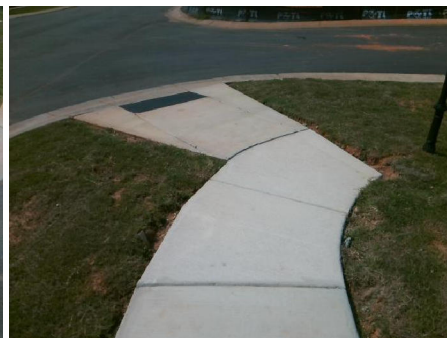
| Compliance | Description | Data | Compliance | Description | Data |
|---|---|---|---|---|---|
| | | | Yes | Surface Condition? (G/P) | Good |
