Access Compliance Report

Public Rights-of-Way

(Curb Ramps)

| Intersection ID: 14546 | Main Street: GREENWOOD_CLIFF | Cross Street: HARDING_PL | Location: | N |

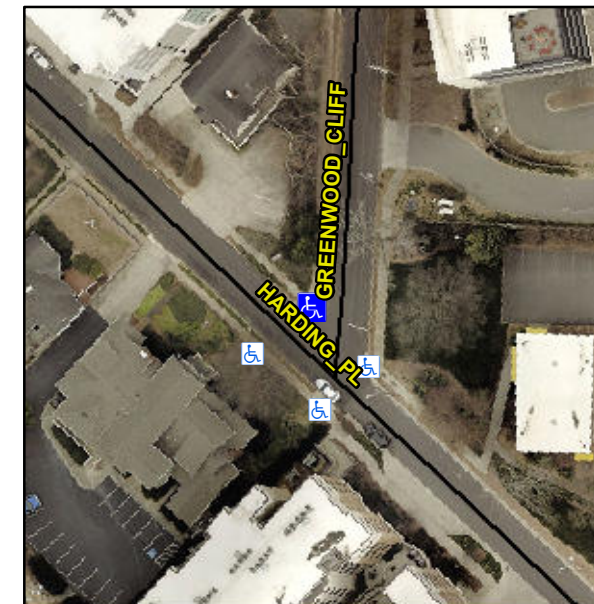
| ADA ID: 446F46AC8B86 | Ramp Type: PerpDiag | Initial Pass/Fail: Fail | Overall Compliance: No | Severity Score: 37.5 |

Not Found, R304.2.2, R304.5.3

| Compliance | Description | Data | Compliance | Description | Data |
|---|---|---|---|---|---|
| N/A | Ramp Length (in) | 96.0 | No | Ramp Slope (%) | 16.1 |
| Yes | Ramp Width (in) | 60.0 | No | Ramp XSlope (%) | 5.5 |

Remove & Replace Curb Ramp With Two New Directional Ramps or Equivalent.

Total Cost: \$ 3200.00
