# Access Compliance Report

## Public Rights-of-Way

| Intersection ID: 14547 | Main Street: EAST_BV | Cross Street: SPRINGDALE_AV | Location: NE |
| ADA ID: 447ADD36FDB2 | Ramp Type: Directional1 | Initial Pass/Fail: Pass | Overall Compliance: No |

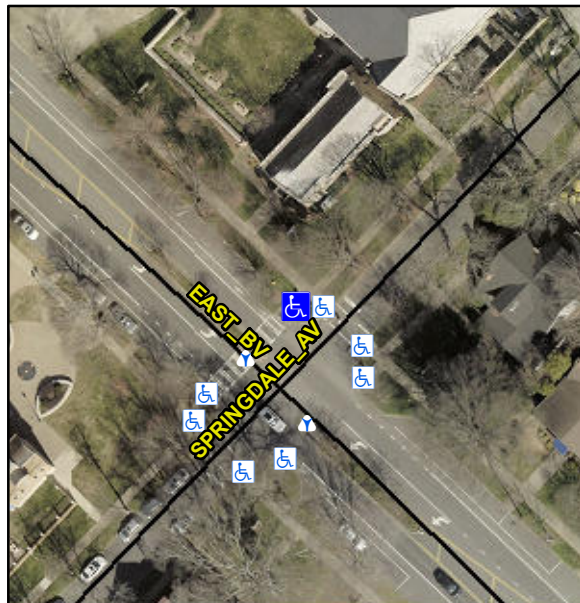
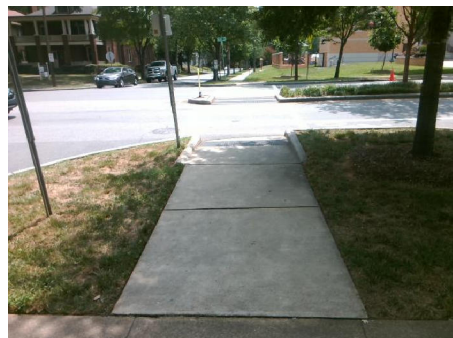
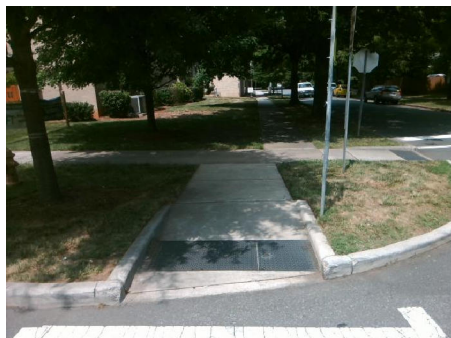
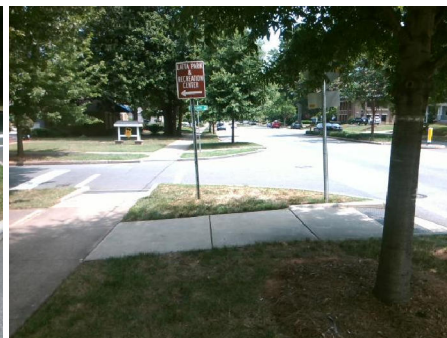
**LNDG SLOPE NEGATIVE**

| Compliance | Description | Data | Compliance | Description | Data |
|---|---|---|---|---|---|
| No | Ramp XSlope (%) | 2.1 | | | |
| No | Landing Slope (%) | 5.4 | Yes | DWS Length (in) | 24.0 |
| Yes | Gutter Lip Ht (in) | 0.0 | No | Gutter X Slope (%) | 2.1 |

**Remove & Replace Entire Ramp.  
Remove & Replace Gutter.**
