Access Compliance Report

Public Rights-of-Way

(Curb Ramps)

Intersection ID: 47099	Main Street: GALLERIA_BV	Cross Street: N/A	Location: SE
ADA ID: 447E11BE9FC6	Ramp Type: Perp	Initial Pass/Fail: Fail	Overall Compliance: No
		Severity Score: 8.75

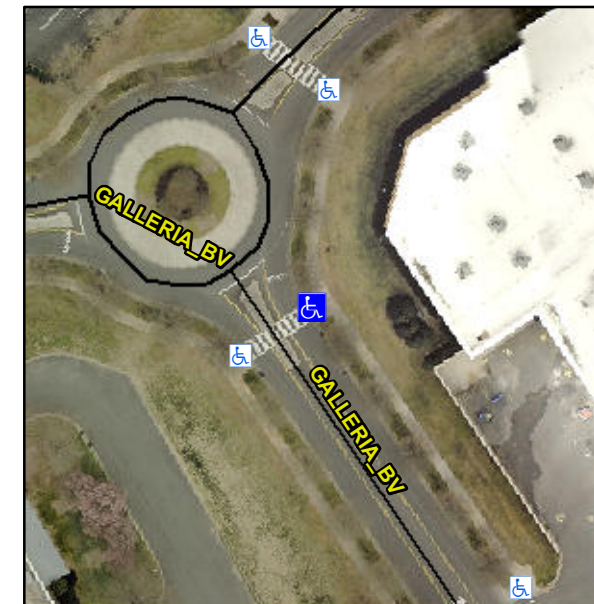
Not Found, R304.5.1

Compliance	Description	Data	Compliance	Description	Data
N/A	Ramp Length (in)	94.5	Yes	Ramp Slope (%)	7.9
No	Ramp Width (in)	45.0	Yes	Ramp XSlope (%)	1.6
N/A	Flare Type LT	N/A	N/A	Flare Type RT	N/A
N/A	Flare Slope LT (%)	N/A	N/A	Flare Slope RT (%)	N/A
N/A	Flare Traversable LT?	N/A	N/A	Flare Traversable RT?	N/A
N/A	Landing Length (in)	N/A	N/A	DWS Provided?	N/A
N/A	Landing Width (in)	N/A	N/A	DWS Contrast?	N/A
N/A	Landing Slope (%)	N/A	N/A	DWS Length (in)	N/A
N/A	Landing X Slope (%)	N/A	N/A	DWS Full Width?	N/A
N/A	Landing Curb? (Y/N)	N/A	N/A	DWS Offset (in)	N/A
N/A	Shared Landing?	N/A			
N/A	Gutter Ponding?	N/A	N/A	Gutter Slope (%)	N/A
N/A	Gutter Lip Ht (in)	N/A	N/A	Gutter X Slope (%)	N/A
N/A	Painted X Walk1?	Yes	N/A	Painted X Walk2?	N/A
	X Walk 1 Direction	To SW		X Walk 2 Direction	N/A
N/A	X Walk 1 Width (in)	98.0	N/A	X Walk 2 Width (in)	N/A
	X Walk 1 Slope (%)	0.8		X Walk 2 Slope (%)	N/A
	X Walk 1 X Slope (%)	0.7		X Walk 2 X Slope (%)	N/A

N/A	Ramp inside XWalk1?	Yes	N/A	Ramp inside XWalk2?	N/A
	Road Slope (%)	N/A	N/A	Clear Space?	N/A
	Road X Slope (%)	N/A	N/A	Clear Space to XWalk (in)	N/A
N/A	Any Obstructions?	N/A	N/A	Storm Grate/Utility Hazard?	N/A
	Obstruction Type			Storm Grate/Utility Type	
		N/A			N/A
			Yes	Surface Condition? (G/P)	Good

Possible Solutions:

Remove & Replace Entire Ramp.

Total Cost: \$ 1850.00
