Access Compliance Report

Public Rights-of-Way

(Curb Ramps)

Intersection ID: 53165	Main Street: DIXIE_RIVER_RD	Cross Street: N/A	Location: NW
ADA ID: 44946EEC2FCE	Ramp Type: Perp	Initial Pass/Fail: Fail	Overall Compliance: No
Severity Score: 25			
Codes/Mitigation Info/Possible Solution		Field Measurements/Component Compliance

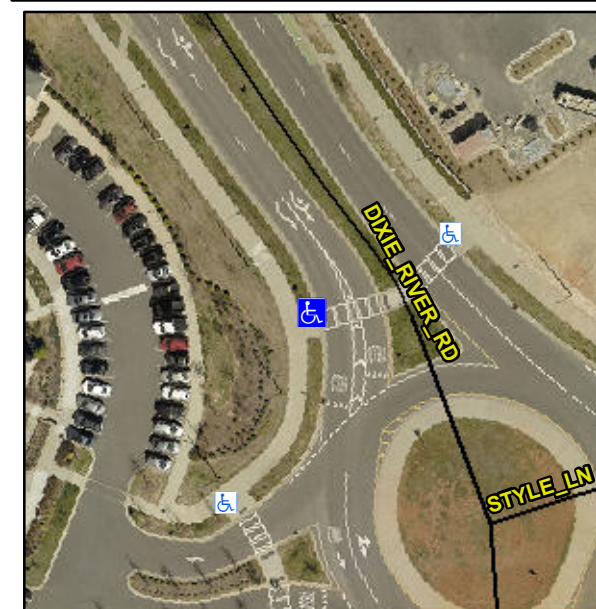
Not Found, R304.2.2, R304.5.3

Compliance	Description	Data	Compliance	Description	Data
N/A	Ramp Length (in)	95.0	No	Ramp Slope (%)	8.8
Yes	Ramp Width (in)	48.0	No	Ramp XSlope (%)	6.6
N/A	Flare Type LT	N/A	N/A	Flare Type RT	N/A
N/A	Flare Slope LT (%)	N/A	N/A	Flare Slope RT (%)	N/A
N/A	Flare Traversable LT?	N/A	N/A	Flare Traversable RT?	N/A
N/A	Landing Length (in)	N/A	N/A	DWS Provided?	N/A
N/A	Landing Width (in)	N/A	N/A	DWS Contrast?	N/A
N/A	Landing Slope (%)	N/A	N/A	DWS Length (in)	N/A
N/A	Landing X Slope (%)	N/A	N/A	DWS Full Width?	N/A
N/A	Landing Curb? (Y/N)	N/A	N/A	DWS Offset (in)	N/A
N/A	Shared Landing?	N/A			
N/A	Gutter Ponding?	N/A	N/A	Gutter Slope (%)	N/A
N/A	Gutter Lip Ht (in)	N/A	N/A	Gutter X Slope (%)	N/A
N/A	Painted X Walk1?	Yes	N/A	Painted X Walk2?	N/A
	X Walk 1 Direction	To E		X Walk 2 Direction	N/A
N/A	X Walk 1 Width (in)	113.0	N/A	X Walk 2 Width (in)	N/A
	X Walk 1 Slope (%)	1.4		X Walk 2 Slope (%)	N/A
	X Walk 1 X Slope (%)	6.2		X Walk 2 X Slope (%)	N/A

N/A	Ramp inside XWalk1?	Yes	N/A	Ramp inside XWalk2?	N/A
	Road Slope (%)	N/A	N/A	Clear Space?	N/A
	Road X Slope (%)	N/A	N/A	Clear Space to XWalk (in)	N/A
N/A	Any Obstructions?	N/A	N/A	Storm Grate/Utility Hazard?	N/A
	Obstruction Type			Storm Grate/Utility Type	
		N/A			N/A
			Yes	Surface Condition? (G/P)	Good

Remove & Replace Entire Ramp.
